長大橋NEWS レター

NEWSLETTER on Long-Span Bridges

No.47

本州四国連絡高速道路株式会社 長大橋技術センター 平成24年1月

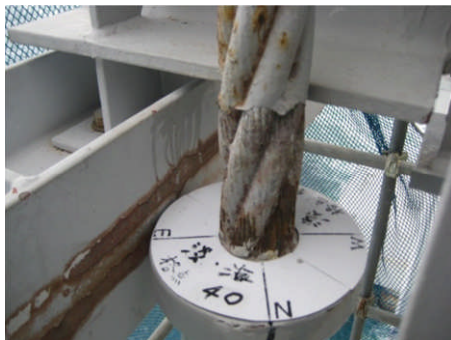
写真-1 ロープ定着部の腐食

Photo-1 Corrosion at Anchoring Part

1985年に開通した大鳴門橋では、ハンガーロープ(以下、「ロープ」という)の定着部近傍に腐食が生じているため、補修を実施しています。ロープの腐食はロープ表面に止まらず、内部への進展が確認されています。そのため、全磁束法による非破壊検査(NEWSレターNo.11参照)により、腐食によるロープの断面減少量を定量的に評価しています。その際、腐食によるロープの断面減少量に着目した管理基準値を定め、断面の定量的評価結果に基づき既存のロープを補修するのか、あるいは取替えを行うのかの判断をしています。これまでに、約320箇所(約80格点)の調査を行いました。著しい腐食によるロープの取替えは1本のみです。

Hanger ropes of the Ohnaruto Bridge, opened to traffic in 1985, have been under repair since corrosion at anchoring parts of the ropes was found. Corrosion of the ropes has been observed not only on the surface of the ropes but in the inside of the ropes. Reductions in the section area of a rope are evaluated quantitatively by a non-destructive test, "Main Flux Method," presented in News Letter No.11. Control criteria were determined by focusing on the reduced section area of a rope due to corrosion. The judgment, whether existing ropes should be repaired or replaced, is decided based on the result of the Main Flux Method and the control criteria. Survey for about 320 ropes (about 80 panel points) has been completed. It was found that only one rope had to be replaced due to severe corrosion.

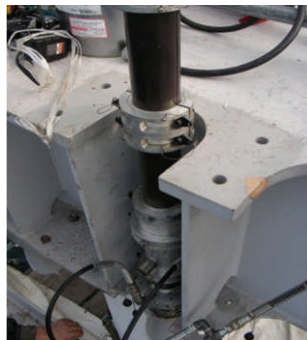
写真-2 防錆材の内部充填

Photo-2 Grouting Anti-Rust Material

補修は、既存のロープの腐食劣化の進展を抑制する目的で、ロープ内部に防錆材を充填するとともに、外面には防食テープを巻き付けることによって防錆力の向上を図っています。一連の調査・補修作業は、予備調査として行った目視による調査の結果において、腐食量が大きいと判断したロープから行っており、これまでに全ロープのおよそ30%の補修を完了しています。今後も計画的に補修を実施する予定です。

Two repair methods were applied in order to prevent the progress of rust on existing ropes and to improve rust-proof performance; one is to fill the inside of a rope with anti-corrosion material and the other is to wrap the outside of the rope with anti-rust tape. A series of survey and repair work for heavily corroded ropes has been conducted, based on the visual inspection conducted as a preliminary investigation. Repair for about 30% of all ropes was completed so far. This repair work is going to be conducted intentionally in the future.

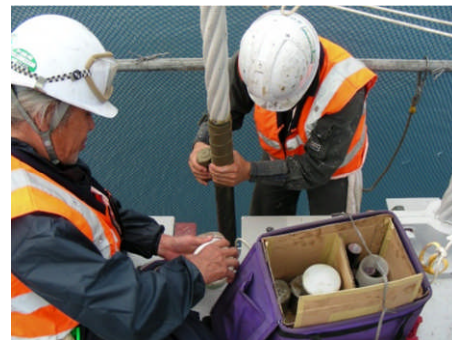
写真-3 外部防食テープ巻付け

Photo-3 Wrapping Anti-Rust Tape

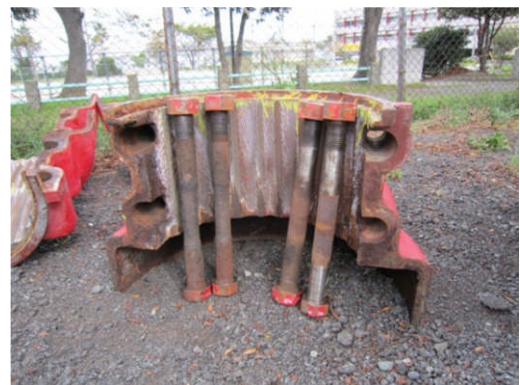
写真-6 バンドボルト取り替え
Photo-6 Exchange of cable band bolts

既設のケーブルバンドボルト($\Phi = 46 \text{ mm}$ ・長さ 480 mm) 1584 本を新規ケーブルバンドボルト($\Phi = 30 \text{ mm}$ ・長さ 600 mm) に取換えます。既設のケーブルバンドボルトは水の影響を受け易い下段側は軸が細っているものも見られる等特異な状況も確認できました。

All of the cable band bolts ($n=1584$ bolts, $\phi = 46\text{mm}$, $l=480\text{m}$) are replaced by new bolts ($\phi = 30\text{mm}$, $l=600\text{m}$). Sectional area of some cable band bolts at lower side is reduced because lower side bolts are influenced by water (photo-6).

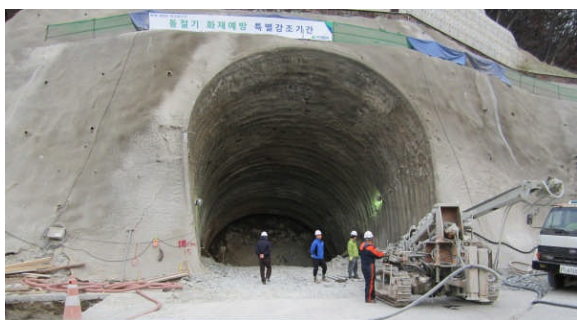
写真-10 トンネルアンカレイジの掘削
Photo-10 Excavation for Tunnel Type Anchorage

ウルサンハーバー大橋では、現在、トンネルアンカレイジの掘削作業が開始したところで、主塔部では2基の基礎工事が終了し、コンクリート製主塔の施工が開始したところです。

At present, excavation for tunnel type anchorage and execution of concrete towers have started after completion of two tower foundation works at the Ulsan Harbor Bridge.
