長大橋NEWS レター

No.39

因島大橋鋼床版縦桁支承の高耐久性化

Durability enhancement of bearings for steel plate decks on the Innoshima Bridge

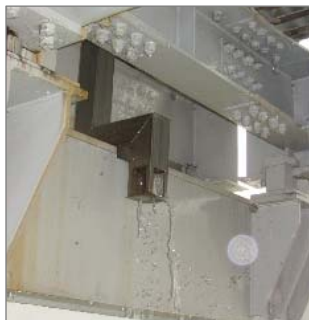
写真-1 排水樋
(Photo 1: Drain gutter)

以前は伸縮継手部に流れ込んできた排水が桁上に落下し、錆汁が広がっていましたが、排水樋を設置し排水がこの部分に落下しないようにしました(写真-1)。また、縦桁を伝わってくる雨水に対しては、水切り板(写真-2)やコーキングの設置(写真-3)を行っています。上脊部に水切りコーキングを設置したところ、支承への雨水の浸入は概ね改善されました。コーキングでの水切りは安価で比較的施工が容易であるため有効な手段だといえます。

Before the installation of the drain gutters (Photo 1), rain water flowed into the expansion and fell on the stringers, and rusty water extended on the stringers. After the installation of the drain gutters, the rain water is well drained through the gutters.

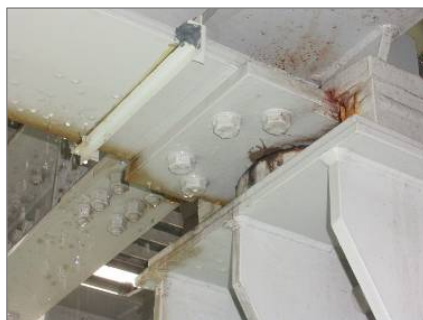
写真-2 水切り板
(Photo 2: Water stop bar)

Water stop bars (Photo 2) and caulking (Photo 3) are installed to block the rain waters running along the stringers. After the installation of the caulking on the upper bearings, the infiltration of rain water into the bearings could be almost interrupted. It can be said that the caulking is efficient measures to improve the waterproofing of the bearings because it is cheap and easy to be installed.

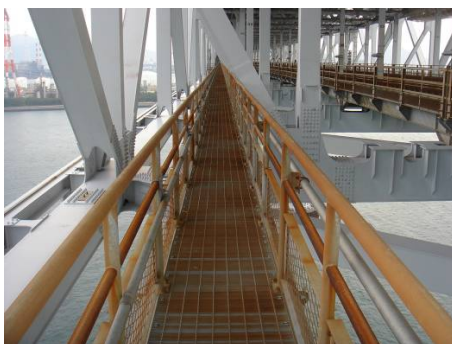
写真-4 管理路劣化状況

全体の 4 割以上のパネルにおいて、既にめっきが消耗し、腐食が鉄素地にまで進行している部位のあること、橋によって劣化の進行に差があることが分かりました。以上の結果、今後、補修塗装・再メッキ・取替などの対策を計画的に実施する必要があることが分かりました。

There were some deteriorated parts in the maintenance ways. More than 40 percent of maintenance ways were observed as grade V, where most of the galvanized layer is consumed, and the corrosion also has progressed on the steel body. And the progress of corrosion was different according to bridge locations.

As the result of the survey, it can be said that the maintenance ways on the Seto-Ohashi Bridges are needed a deliberate countermeasure such as touch-up paintings, re-galvanizings and replacements.

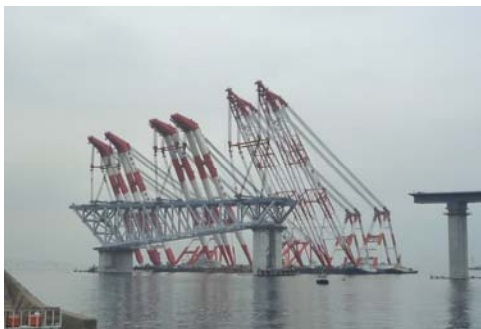
写真-5 東京港臨海大橋(仮称)のトラス桁架設
(Photo 5: Truss girder erection of Tokyo Bay Bridge)

現在、主橋梁の上部工工事を実施中です。今年 9 月には国内最大の起重機船 3 隻による大ブロック一括架設を 2 回実施し、両側径間の下部トラス桁(重さ約 6 千トン、長さ 232m×幅 24m×高さ 35m)を架設しました。今後、上部トラス部材の単材架設後に、中央径間のトラス桁および箱桁を大型起重機船 1 隻で大ブロック一括架設する予定です。

Currently, the superstructure of the major bridge is under construction. In September 2009, large-block erections were carried out twice, in which the lower truss girder (weight: 6000tons, length: 232m, width: 24m, height: 35m) for each side span was erected by three of the largest floating cranes in Japan. After erection of each upper truss member, a large-block erection of truss girders and box girders for the main span will be erected by a large-scale floating crane.
