## JB 本四高速情報

### 多々羅大橋のケーブル近接点検における取組

## Activity of HSBE

### Efforts for close visual inspection of the Tataru bridge cables

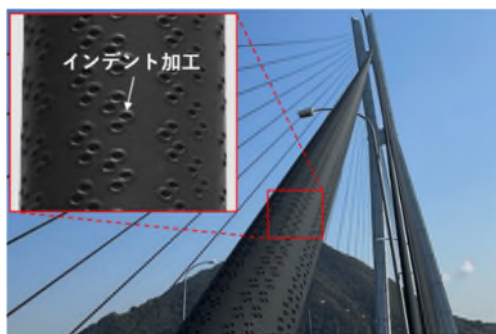
写真-1 インデント加工  
Photo 1 Indent pattern

多々羅大橋（斜張橋：L=1,480m）のポリエチレン被覆されたケーブル表面（168 本）を観察したところ、一部で微小な亀裂が確認されました。そのため、路面から 2m の高さまで、調査したところ、47 本で同様の亀裂が確認されました。発生形態は、インデント加工された円周部や底部に多く、発生位置は、側径間かつケーブル上面に集中していました。亀裂が確認された 47 本中 24 本について、ケーブル表面被覆（t=10mm）を削孔し、深さ方向の断面観察を行った結果、疲労亀裂特有のビーチマークが確認されました。亀裂深さは最大で 4mm でした。また、削孔したケーブルのうち、2 本において、素線の白さびやさびが一部確認されました。

These cracks were predominantly found at circumference and bottom of the indent of the cables, with a concentration on the upper side between the side spans. Cross-sectional observation was conducted on 24 of the 47 cracked cables by drilling into the 10 mm-thick surface coating. This revealed "beach marks," characteristic of fatigue cracks. The maximum crack depth was 4 mm. In addition, two of the drilled cables showed partial presence of white rust and rust on the steel wires.

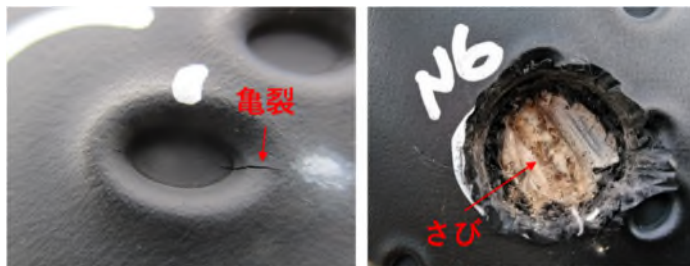
写真-2 インデント加工部の亀裂と削孔後の素線状況  
Photo 2 Crack Formation in Indented Sections and Condition of Steel Strands After Drilling

インデント円周端の亀裂 削孔後の素線状況

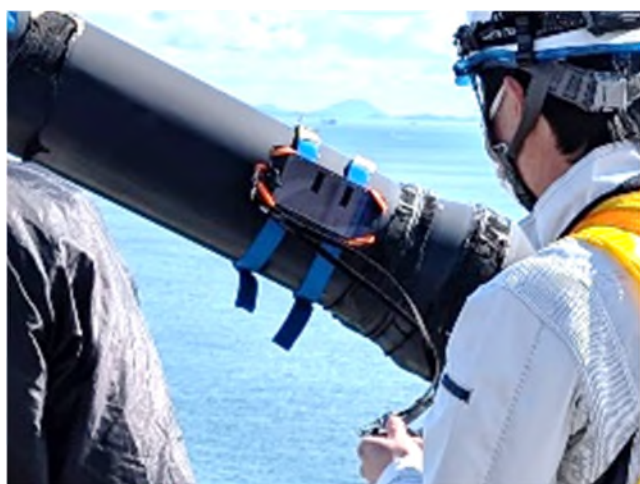
写真-3 ケーブル張力の測定状況  
Photo 3 Cable tension measurement

このため斜張橋ケーブルの張力測定の経済性と作業性の向上を図ることを目的に、垂直な吊橋ハンガーロープの張力測定で実績のあるスマートフォン1つでケーブルの加速度を測定し固有振動数を特定する「テンションリーダー」を斜張橋ケーブルに適用する試験を実施し従来方式との比較を行いました。

Therefore we conducted the cable tension measurement with “Tension Reader”, which can measure the acceleration and natural frequency for suspender ropes in suspension bridges with a smartphone, and compared with the conventional method to improve the economy and workability of cable tension measurement in cable-stayed bridges.

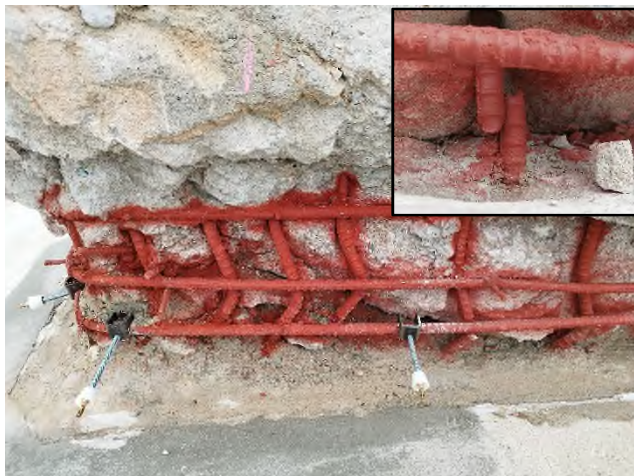
写真-4 P3橋脚基部の被害状況

令和6年1月1日16時10分に発生した能登半島地震は、マグニチュード7.6、深さ約16km、石川県輪島市と志賀町で震度7を観測し、「ツインブリッジのと」においても、支承の損傷や脱落により、橋桁と橋台の間に約40cmの段差が生じたり、橋脚基部の鉄筋の破断や変形、箱桁部のPC鋼材が露出したりするなどの被害が発生し、通行止め措置を行うこととなりました。特に損傷の大きかったP3橋脚基部については、3方面で鉄筋の破断が確認され、ほとんどの鉄筋に塑性変形が確認されました。

Photo 4 Damage to the base of the Pier 3

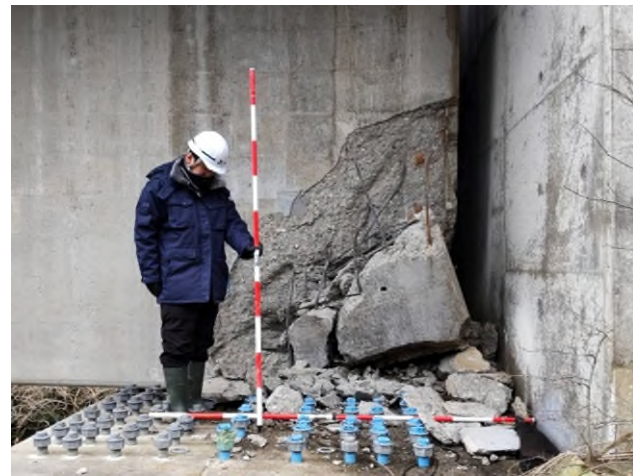
写真-5 箱桁端部の被災状況

Photo 5 Damage to the end of the box girder

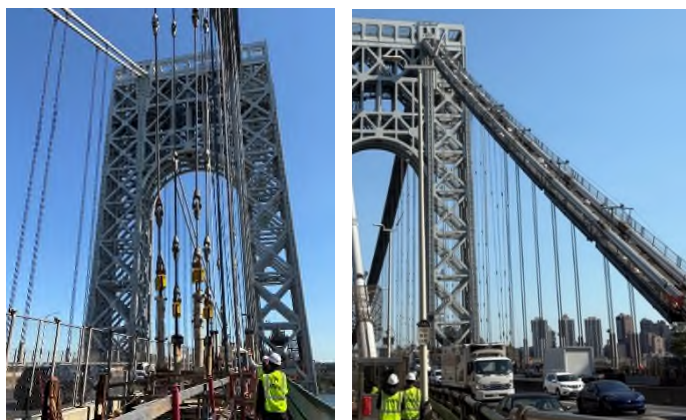
写真-6 (左)ハンガーロープ取替工、(右)主ケーブルの足場

592 本のハンガーロープ取替工は、7 年間にわたる複雑で緻密な作業となりました。各格点のロープ取替では、橋の重量を支えるために架替対象とその隣接する格点において仮ロープを設置し、その後現ロープを取り外しました。その後、新しいロープを橋桁に取り付けて固定し、最後に仮設ロープを取り外しました。作業は、道路交通を確保しながら完了しました。ハンガーロープの長さは、11m から 205m でした。ハンガーロープ取替工は 2018 年の 9 月に開始し、2025 年 3 月に完了しました。

Photo 6 (Left) Replacement of suspender ropes, (Right) Scaffolding under the main cable

Replacing each of the bridge's 592 suspender ropes was a complex, meticulous process over seven years. At each panel point along the bridge, crews secured temporary ropes being replaced as well as the adjacent panel points to support the bridge's weight at that location, then disconnected and removed the original ropes. Crews then installed and secured the new ropes to the span's girders, finally disconnecting the temporary ropes. The work was accomplished while allowing traffic to continue flowing across the span. The suspender ropes range in length from 11m to 205m. The replacement work started in 2018 September and finished in 2025 March.

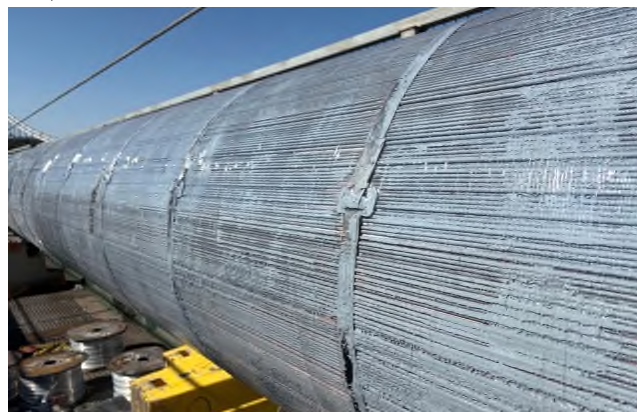
写真-7 主ケーブルの塗替塗装工  
Photo 7 Recoating of the main cable

主ケーブル改修工では、主ケーブル 1 本あたり 26,474 本の素線を有する主ケーブルに対して、塗替塗装及び再ラッピングが行われました。主ケーブルの更なる長寿命化のために、ゴムラッピングに加えて、ケーブル内の湿度を低減するためのケーブル送気乾燥システムが設置されました。

As to the rehabilitation of the main cable, the 26,474 compacted wires within each cable were recoated and rewrapped. To further extend the lifespan of the main cables, a new elastomeric wrap was added, along with a new dehumidification system to reduce moisture within the cables. (This information was provided by Port Authority of NY & NJ.)
