JB 本四高速情報

新たな送気モニタリングシステム「DRIoT」の導入

吊橋ハンガーロープ定着部周辺のひずみ測定による張力変動推定に関する検討

海外(デンマーク)における赤外線カメラによる疲労亀裂検出技術の適用性確認

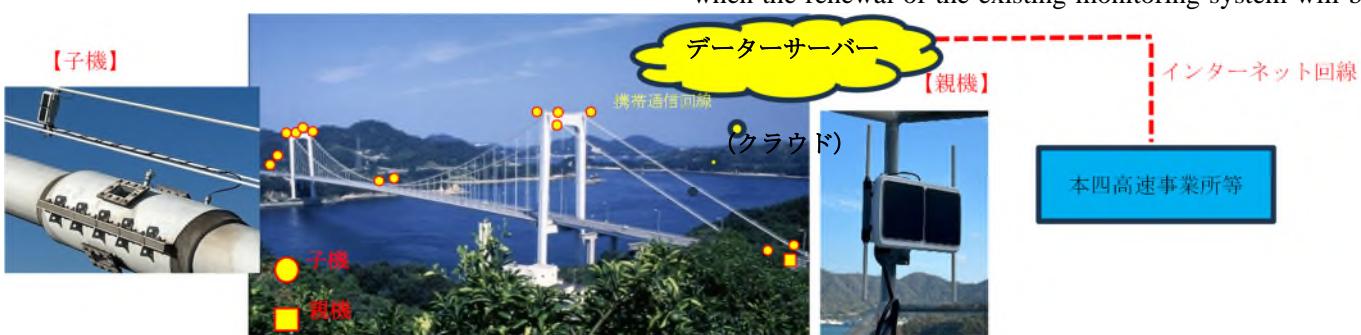
図-1 DRIoT イメージ図

Fig 1 DRIoT image

そこで、大島大橋では主ケーブル上での作業を軽減するために計測センサから記録装置までの配線を無くし、無線化することで遠隔で自動モニタリング可能な手法を開発しました。本手法は、近年のIT技術の発達により、低電力での無線通信技術や自己発電パネル等のモジュールが安価に供給されていることに着目した開発です。

2022年度から2024年度にかけて、無線通信機及びモニタリングソフトの仕様検討、試作器の製造・実橋での通信試験および閲覧アプリの試作等を実施し、2025年度に大島大橋の自動モニタリング機器の更新に併せて、新たな送気システムの温湿度自動モニタリング「DRIoT（ドライオット）」として導入しました。

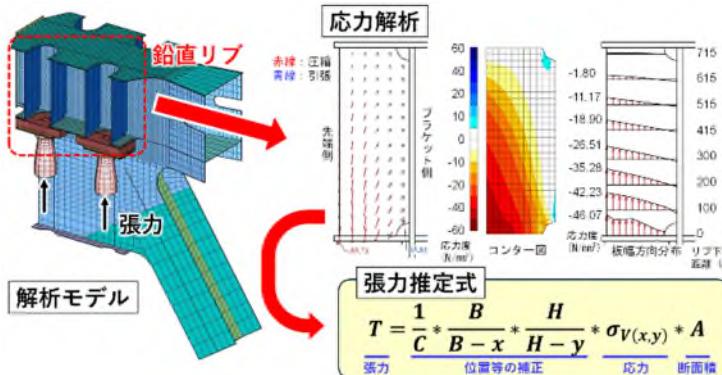
図-2 ハンガー張力変動推定手法の解析的検討

Fig. 2 Analytical study of suspender rope tension

そこで、ハンガーフレーム（鉛直リブ）に着目し、活荷重等によるハンガーの張力変動に伴って補剛材に発生する応力変化から、ハンガー張力変動を簡便に推定する手法の検討を行いました。具体的には、瀬戸大橋の吊橋ハンガーブラケットを対象とした解析モデルを作成し、ハンガーフレーム周辺における応力解析からハンガー張力と補剛材に発生する応力の関係性を整理することで、推定手法の提案を行いました（図-2）。

To address these limitations, we focused on the stiffeners (vertical ribs) at the suspender anchorage and explored a simple method to estimate suspender tension variation from the stresses induced in these stiffeners. An analytical model of the suspender brackets was developed, and stress analysis around the suspender anchorage clarified the relationship between suspender tension and the stress generated in the stiffeners. Based on this, an estimation approach was formulated.

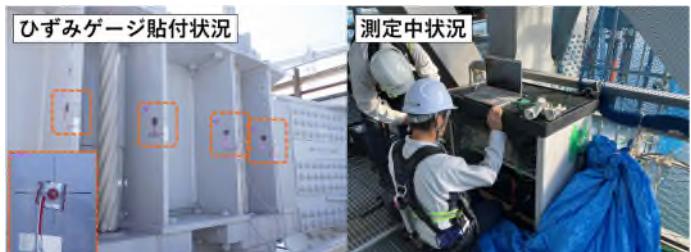
写真-1 ハンガー架替時における実橋測定状況

Photo 1 Measurement at suspender rope

また、瀬戸大橋のハンガーフレーム取替工事に合わせて実橋測定を行い（写真-1）、定着部補剛材のひずみ値から推定した張力変動と、ロードセルにより直接測定した張力変動を比較した結果、図-3のように両者の値にはおおむねの整合性が確認されたことから、定着部補剛材におけるひずみ測定を通じてハンガーの張力変動を推定できる可能性が示唆されました。今後、活荷重に伴うハンガー張力変動を把握する必要性が生じた際等において、本手法の活用が期待できると考えています。

Field measurements were conducted on the suspenders. Suspender tension variations estimated from strains measured on the anchorage stiffeners were compared with those directly measured by load cells. The results showed generally good agreement, indicating that suspender tension can potentially be estimated through strain measurements at the anchorage. This method is expected to be useful for monitoring tension variations caused by live loads.

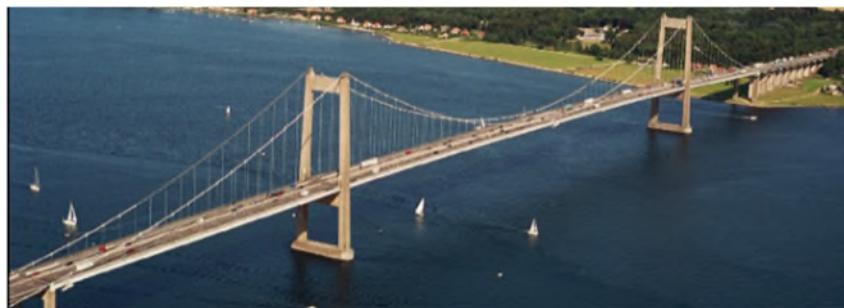
写真-2 リトルベルト橋

Photo 2 Little Belt Bridge

The Little Belt Bridge is a suspension bridge located between the island of Funen and the mainland of Jutland in Denmark. This bridge was opened to traffic in 1970 and has a main span of 600m and two side spans of 240m for a total length of 1,080m.

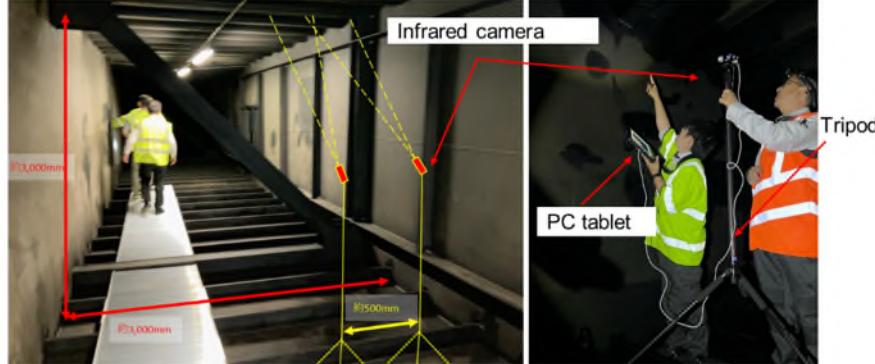
写真-3 亀裂調査状況

Photo 3 Detection of Cracks

結果は、曇天であったため、0.3°C程度の温度差であったものの、3つの新たな亀裂を検出しています。

As a result, though temperature gap between the deck plate and the trough-rib was approximately 0.3°C due to overcast conditions, 3 cracks were detected by T-gap method. These results indicate that this method is applicable to these bridges.

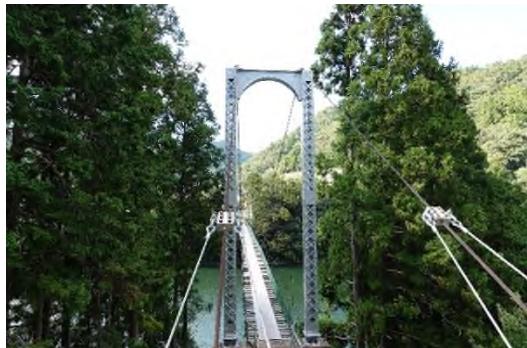
写真-4 猿飼橋

Photo 4 Sarukai Bridge

まず視察した猿飼橋は1960年頃に完成した橋長約143mの単径間人道吊橋です。2015年12月の定期点検でIV判定となり通行止めされました。昨年3月までの工事によりケーブル定着部の補強などが行われています。その後の意見交換会ではメンテナンス課題の解決に向け、技術協力継続を相互に確認しております。

Sarukai bridge is a single-span suspension bridge for pedestrians which was completed around 1960. This bridge had been closed since the regular inspection, which was conducted in December, 2015, was classified as Grade IV (Urgent measure required). In the inspection tour, the reinforcement status of cable fixing section after the repair and reinforcement work was checked. And the continuation of the technical cooperation was mutually confirmed.
