JB 本四高速情報

道路鉄道併用吊橋のハンガーロープ取替えに係る安全性照査

南備讃瀬戸大橋のハンガーロープ取替工事

名港中央大橋における斜材ケーブル補修の 取り組みについて

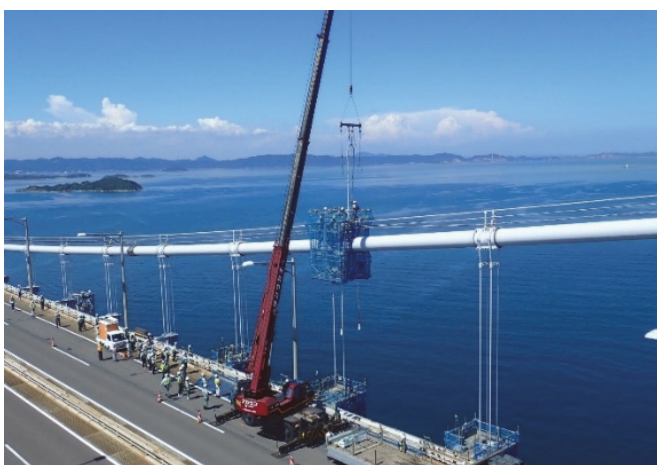
写真-1 旧ロープの撤去状況
Photo 1 Situation of the Removal of Old Suspender Ropes

南備讃瀬戸大橋のハンガーロープは撚り線であり、旧ロープ撤去時（張力開放時）に撚り戻りが発生するため、ハンガーロープのソケット部付近に回転防止治具を設置し、4 箇所同時・同圧で引き込むことで安全に撤去を行いました。旧ロープ撤去前にロードセルを用いて取替対象付近のロープの張力を調査した結果、張力にばらつきが確認されたため、調整プレートを用いて張力調整を行いました。設置する新ロープもロードセルを用いて設計通り均等に張力導入を行いました。

Because the suspender ropes of the bridge are stranded wires, these may be loosened during replacing. To prevent these from loosening, anti-rotation devices were installed around sockets of the suspender ropes. And the old suspender ropes were removed safely by pulling at four points with equal pressure in simultaneously.

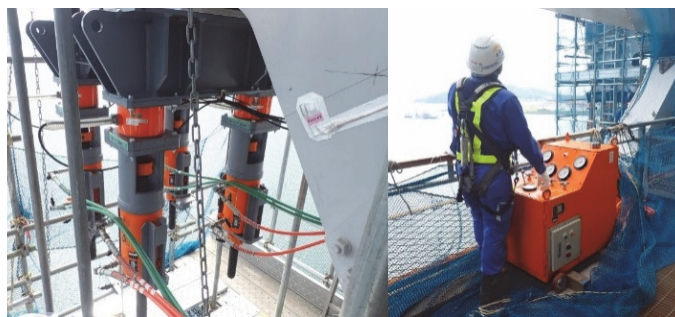
写真-2 新ロープ設置時の張力調整状況
Photo 2 Tension Adjustment during the Installation of new suspender ropes

In addition, before removing the old suspender ropes, it was found that the tensions of the suspender ropes adjacent to replacing suspender ropes varied by the tension measurement using load cells. Therefore, these tensions were adjusted by adding steel plates. The tensions were also applied evenly to the new suspender ropes according to design values.

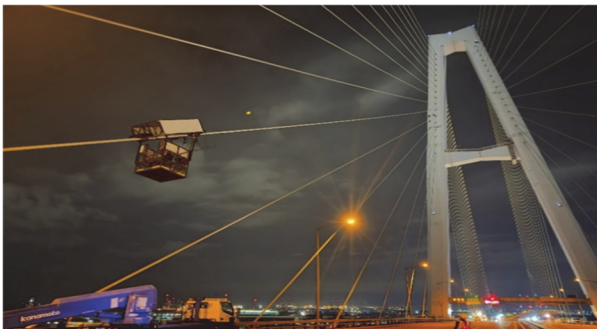
写真-7 施工状況
Photo 7 Repair Work Situation

今回行った斜材ケーブルの補修は、作業高さ最大約 80m の高所作業であり、通行車両の安全確保のため上下線通行止め規制内で施工しました。交通影響を最小限とするため、規制時間は 23 時から翌 6 時までの夜間に限定しました。高所作業はロープアクセスで実施し、新たに設計・製作した資材運搬用台車を用いました。この台車は、様々なケーブル角度や外径に対応可能な構造としました。補修方法は、損傷箇所を熱収縮チューブで塞ぎ、自己融着テープおよびステンレスカバーで被覆しました。また、桁側定着部に滞水が確認されたため、桁側定着部の保護管を開孔し内部の水を吸引除去しました。

The repair work of stay cables was conducted at high places up to approximately 80 meters and with the road closed to ensure the safety of passing vehicles. In order to minimize the traffic impact, the road closure time was limited to the nighttime period from 23:00 to 6:00 the following day. The repair work at high places was conducted using rope access and the newly designed and manufactured stay cable gondola for transporting repair materials. The gondola was designed to adjust various cable angles and outer diameters. As a repair method, the damaged parts were closed with heat shrinkable tubes, and self-adhesive tape was wrapped around the tube, and then stainless-steel covers were installed. And water pooling was found at the inside anchorage zones, so the protective pipes were partially opened and inside water was removed by sucking.

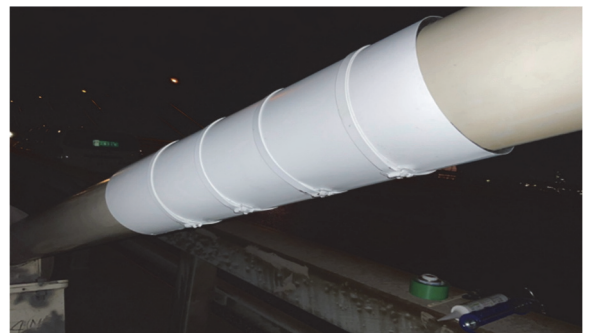
写真-8 補修完了（ステンレスカバー設置状況）
Photo 8 Installation of Stainless-Steel Covers

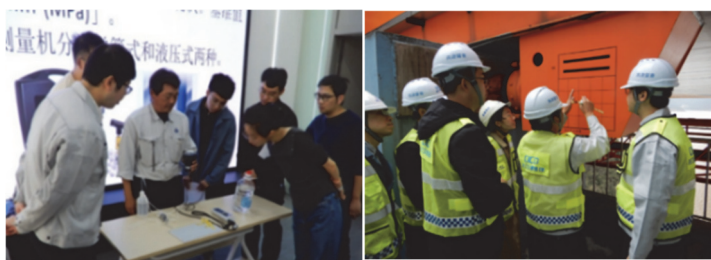
写真-12 室内・実橋トレーニングの様子
Photo 12 Indoor and On-site Training Sessions

まず、先方の橋梁技術センターにおいて、本四高速グループの長大橋の塗膜維持管理に関する基本的な考え方の共有と塗膜劣化予測手法についての講義を行ったのち、劣化予測等に必要と定量的なデータを取得するための塗膜調査機器の使用法の室内トレーニングを実施しました。
