長大橋NEWS レター

わたう、せとう。
No.47

大鳴門橋ハンガーロープ調査・補修

Repair of Hanger Ropes of the Ohnaruto Bridge

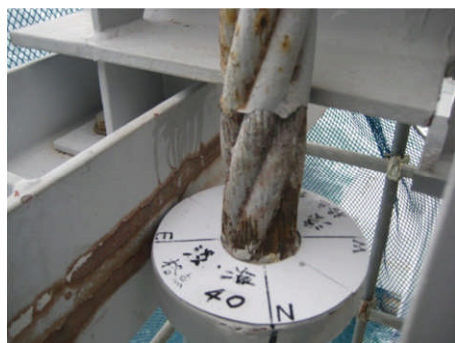
1985年に開通した大鳴門橋では、ハンガーロープ（以下、「ロープ」という）の定着部近傍に腐食が生じているため、補修を実施しています。ロープの腐食はロープ表面に止まらず、内部への進展が確認されています。そのため、全磁束法による非破壊検査（NEWS レターNo.11 参照）により、腐食によるロープの断面減少量を定量的に評価しています。その際、腐食によるロープの断面減少量に着目した管理基準値を定め、断面の定量的評価結果に基づき既存のロープを補修するのか、あるいは取替えを行うのかの判断をしています。これまでに、約320箇所（約80格点）の調査を行いました。著しい腐食によるロープの取替えは1本のみです。

Hanger ropes of the Ohnaruto Bridge, opened to traffic in 1985, have been under repair since corrosion at anchoring parts of the ropes was found. Corrosion of the ropes has been observed not only on the surface of the ropes but in the inside of the ropes. Reductions in the section area of a rope are evaluated quantitatively by a non-destructive test, "Main Flux Method," presented in News Letter No.11. Control criteria were determined by focusing on the reduced section area of a rope due to corrosion. The judgment, whether existing ropes should be repaired or replaced, is decided based on the result of the Main Flux Method and the control criteria. Survey for about 320 ropes (about 80 panel points) has been completed. It was found that only one rope had to be replaced due to severe corrosion.

写真-1 ロープ定着部の腐食

Photo-1 Corrosion at Anchoring Part

補修は、既存のロープの腐食劣化の進展を抑制する目的で、ロープ内部に防錆材を充填するとともに、外面には防食テープを巻き付けることによって防錆力の向上を図っています。一連の調査・補修作業は、予備調査として行った目視による調査の結果において、腐食量が多いと判断したロープから行っており、これまでに全ロープのおよそ30%の補修を完了しています。今後も計画的に補修を実施する予定です。

Two repair methods were applied in order to prevent the progress of rust on existing ropes and to improve rust-proof performance; one is to fill the inside of a rope with anti-corrosion material and the other is to wrap the outside of the rope with anti-rust tape. A series of survey and repair work for heavily corroded ropes has been conducted, based on the visual inspection conducted as a preliminary investigation. Repair for about 30% of all ropes was completed so far. This repair work is going to be conducted intentionally in the future.

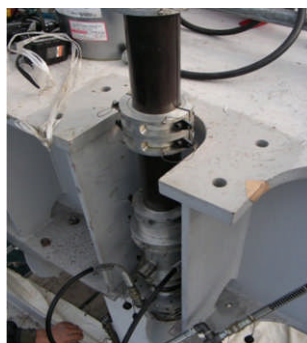
写真-2 防錆材の内部充填

Photo-2 Grouting Anti-Rust Material

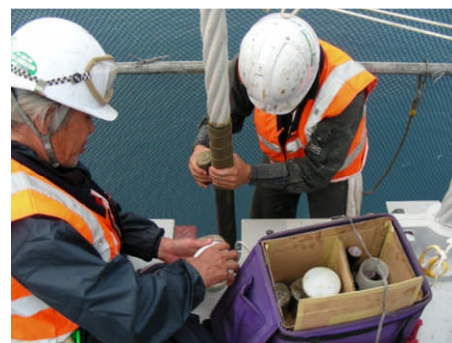
写真-3 外部防食テープ巻付け

Photo-3 Wrapping Anti-Rust Tape

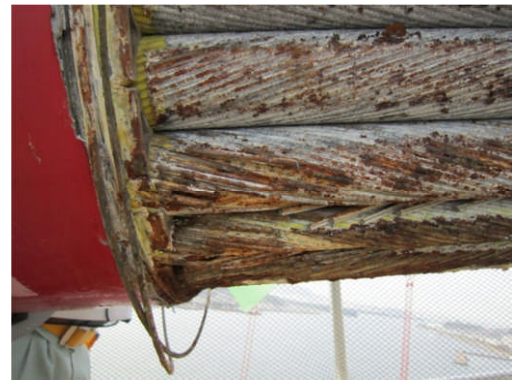
主ケーブル中央部分の2格点間(延長 16.8m)のラッピングワイヤーを撤去して、コア部分の状況を観察しましたが、極めて健全でした。バンドを撤去したところバンドと主ケーブルの接点部分において素線の破断が数多く確認されました。その事象を踏まえ設置条件の厳しいバンド部の調査を追加します。

Two panels (16.8m) of wrapping wires were removed and the inside condition of the main cable was investigated. The inside condition is very sound. Breakage of many wires was found at the contact points between the main cable and cable bands when cable bands were removed. Additional investigation of cable bands under more severe condition has been conducted based on the above result (Photo-5).

写真-5 主ケーブル調査
Photo-5 Main cable investigation

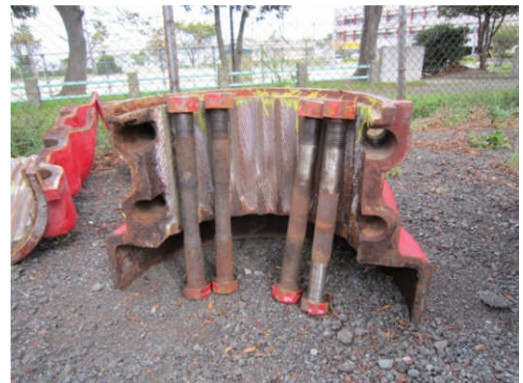
既設のケーブルバンドボルト($\Phi = 46 \text{ mm}$ ・長さ 480 mm) 1584 本を新規ケーブルバンドボルト($\Phi = 30 \text{ mm}$ ・長さ 600 mm)に取換えます。既設のケーブルバンドボルトは水の影響を受け易い下段側は軸が細っているものも見られる等特異な状況も確認できました。

All of the cable band bolts ($n=1584$ bolts, $\phi = 46 \text{ mm}$, $l=480 \text{ mm}$) are replaced by new bolts ($\phi = 30 \text{ mm}$, $l=600 \text{ mm}$). Sectional area of some cable band bolts at lower side is reduced because lower side bolts are influenced by water (photo-6).

写真-6 バンドボルト取り替え
Photo-6 Exchange of cable band bolts

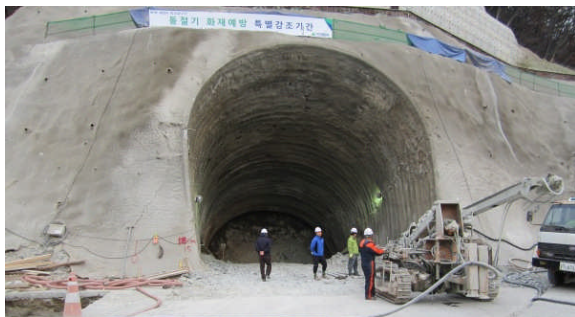
ウルサンハーバー大橋では、現在、トンネルアンカレイジの掘削作業が開始したところで、主塔部では2基の基礎工事が終了し、コンクリート製主塔の施工が開始したところです。

写真-10 トンネルアンカレイジの掘削
Photo-10 Excavation for Tunnel Type Anchorage

At present, excavation for tunnel type anchorage and execution of concrete towers have started after completion of two tower foundation works at the Ulsan Harbor Bridge.
