長大橋NEWS レター

No.49

本州四国連絡高速道路株式会社 長大橋技術センター 平成 24 年 7 月

明石海峡大橋主塔制振装置の維持管理の合理化

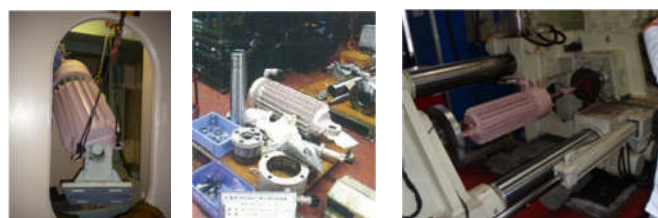
Carrying out of the damper from the tower

Overhaul

Performance tests

写真-1 ダンパーの分解整備
Photo.1 Overhaul of the dampers

明石海峡大橋（1998年完成）の主塔は、海面上約300mと高く鋼製で可撓性があるため、風により揺れやすい構造になっています。風による振動（渦励振）を抑える対策として、塔柱にTMD（質量同調式ダンパー：20基/塔）、側径間側補剛桁との間にオイルダンパー（4基/塔）が設置されています（図-1）。これらのダンパーには、所要の性能を維持するための定期的な分解整備（写真-1）に多くの費用が必要となります。そこで、建設時以降に得られた知見から、ダンパーの分解整備サイクルの長期化などのコスト縮減に関する検討を行っています。

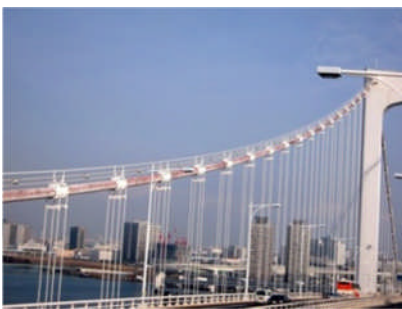
写真-2 主ケーブル劣化状況
Photo.2 Deterioration of main cable

写真-3 コーキング劣化状況
Photo.3 Deterioration cable band caulking

レインボーブリッジは、平成5年8月に供用を開始してからおよそ19年が経過し、主ケーブルについては全般に塗膜の劣化状況が目視で確認できる状況となっています（写真-2, 3）。

主ケーブルの塗装仕様は、図-2に示すように防水材料であるクロロプレンゴム系塗料の上に耐候性のあるクロロスルフォン化ポリエチレン塗料を上塗りしたもので、ケーブルの表面に表れている赤褐色は、経年劣化により上塗塗料が消耗し下塗塗料が露出したものです。

RAINBOW-Bridge is about 19 years old since its opening to the traffic on August 1993, and the deterioration of main cable's paint can be seen by visual observation on the whole (photo. 2,3).

Main cable's paint system is shown in figure-2. The lower paint is the chloroprene rubber paint as a waterproofing material, and the upper paint is the chlorosulfonated polyethylene paint as a weather resistance material. Reddish brown paint which appears on the surface of the cable in the photos is the lower paint because the upper paint was exhausted by aged deterioration.

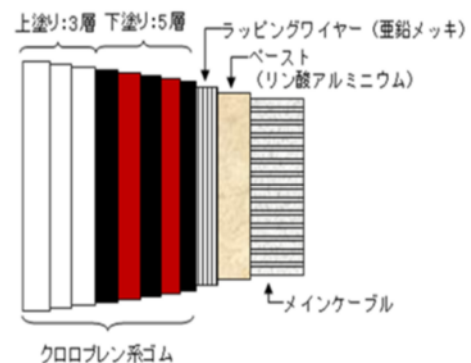
図-2 主ケーブル防錆システム
Fig.2 Anti-corrosion system for main cable

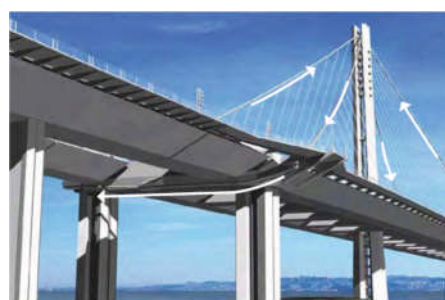
写真-8 自碇式吊橋（完成予想図）
Photo.8 Self-Anchored Bridge (Conception drawing)

その他にも長大橋調査として、カリフォルニア州運輸局にて、サンフランシスコオークランドベイブリッジ東区域の自碇式吊橋建設状況（写真-8）、また、ワシントン州運輸局ではタコマ・ナロウズ橋等を調査しました。

In addition to above issues, the mission team had site surveys to several long spanned bridges, such as the new self-anchored suspension bridge (Photo.8 under construction at the east side of the San Francisco Oakland Bay Bridge) and the Tacoma Narrows Bridges.
