長大橋NEWS レター

NEWSLETTER on Long-Span Bridges

No.51

本州四国連絡高速道路株式会社 長大橋技術センター 平成 25 年 1 月

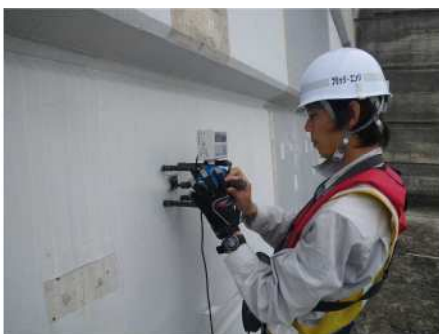
写真-1 塗膜の付着力試験

Photo.1 Adhesion test of coating

このような状況から、本四高速では過去に実施した試験施工も含めた既設のマスコンクリート塗装について、調査を実施しています。外観、付着力、のび性能、遮塩性、中性化阻止性、などの現時点での性能確認に加え、原因が不明な劣化形態については、種々の試験を行いその原因究明にも取り組んでいます。これらの成果をとりまとめ、マスコンクリート塗装基準の策定、さらにはこれらの塗装の適正な維持管理に向けた新たなマニュアル作りに取り組んでいます。

Because of abovementioned background, the Honshu-Shikoku Bridge Expressway (HSBE) is conducting survey of existing mass concrete coating including exposed test specimens. In addition to grasp current performance such as appearance, adhesion, elongation characteristic, chloride ion blocking performance, carbonation protection, and so forth, the HSBE is tackling to find causes of unexplained deteriorations through various tests. By summarizing these results, the HSBE is trying to establish a specification for mass concrete coating and, furthermore, a manual for appropriate maintenance for these coating system.

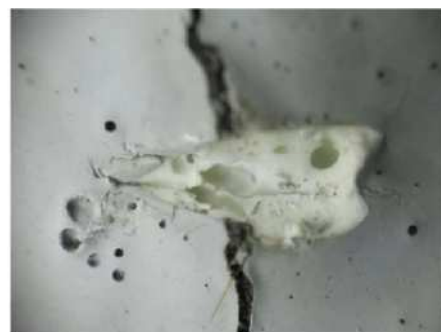
写真-2 塗膜内部の状態観察

Photo.2 Observation of inside layer of coating

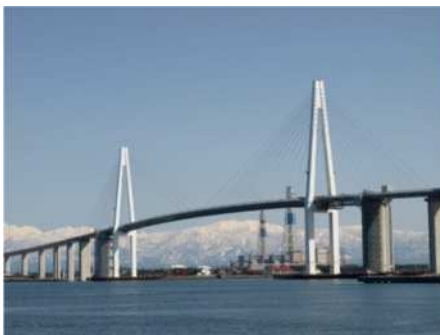
写真-3 新湊大橋の全景
Photo.3 Shin-Minato Bridge

臨港道路は総延長 3.6km、主橋梁部である新湊大橋は、主塔の高さ 127m、全長 600m(中央径間 360m)海面から桁下までの高さ 47m を確保した富山新港の主航路を跨ぐ日本海側最大級の斜張橋です。斜張橋の構造は、経済性・構造性を検討し、主桁を鋼箱桁、側径間(120m)を PC 箱桁とする 5 径間連続複合斜張橋としました。

新湊大橋は、主塔の形状として A 型を採用し、色は白に統一することにより名峰:立山連峰を背景に周囲とも調和する美しくシャープなデザインとなっており、地域のにぎわい創出の拠点として、期待されています。

The road is 3.6km long and the Shin-Minato Bridge (total length of 600m with center-span length of 360m, main tower height of 127m, and clearance of 47m above the surface of the sea) is the one of the largest cable-stayed bridges in the coasts facing the Sea of Japan. Five-span continuous hybrid cable-stayed bridge with prestressed concrete box girder for the side span is accepted in order to achieve economic and structural rationality.

By adopting A-shaped main tower and white color, the Shin-Minato Bridge has beautiful and sharp design which harmonizes with the surrounding, having Tateyama mountain range as background. And also, it is expected as a base of the local rejuvenation.

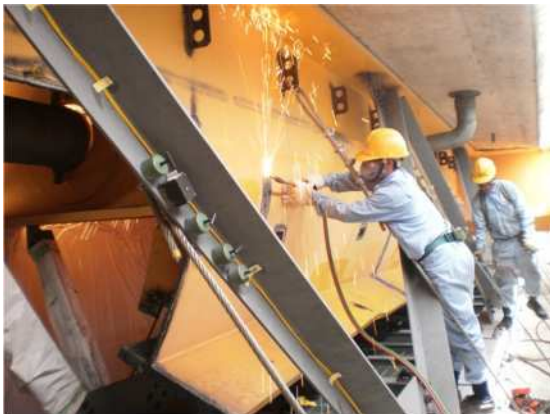
写真-5 損傷桁切断
Photo.5 Cutting damaged girder

主桁の取替えは、仮設桁を設置し一時的に桁の応力を受け持たせ、損傷箇所の切断・撤去を行い、新しく製作した部材を溶接により設置しました。この各段階では、応力の変動をモニタリングしながら慎重に作業が進められました。ケーブルは仮ハンガーケーブル取替え工法により新しいケーブルに取替えを行っています。

The replacement of the girder was conducted by transferring the stress to temporary girders, cutting and removal of damaged portion, and installation of new member by welding. In each step, work was conducted carefully by monitoring the change of the stress. Cables were replaced using a temporary hanger system one by one.
