JB 本四高速の活動

工業用内視鏡による狭隘部の点検

レインボーブリッジケーブル送気乾燥システムの試験稼働

イズミット湾横断橋

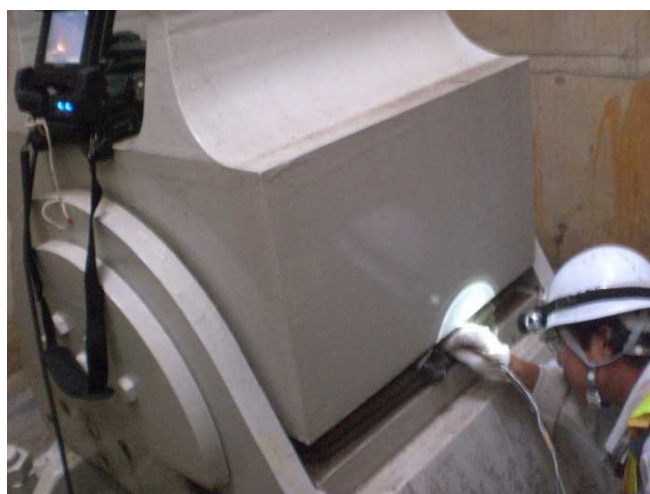
写真-1 調査状況
Photo.1 Under investigation

このため、工業用内視鏡を適用して、構造物の状態を把握するための調査を3年間かけて行ってきました。調査は、まず各長大橋を管理している担当部署に点検困難箇所をアンケート調査し、適用性が高い部位を抽出しました。その中から、比較的損傷発生しやすい箇所を抽出し、順次現地調査していきました。また、並行して工業用内視鏡を適用した場合の課題についても整理し、その解決方法についても検討しました。具体的には、内視鏡のケーブル剛性が小さいことや撮影箇所の特が難しいことなどがありました。具体的な適用箇所として、吊橋ケーブルの主塔やアンカレイジの進入部にあるケーブルカラー内面、サドル部、アンカレイジケーブル定着部、斜張橋のケーブル定着構造部、鋼床版Uリブ内面、リンク支承等を調査しそれぞれの部位における工業用内視鏡の挿入方法、位置確認方法等を確認しつつ、点検方法を確立していきました。

Therefore, a new investigation method using the industrial fiberoscope has been studied for three years. At first, questioner survey to sections in charge of maintenance on long span bridges had been done in order to pick up points difficult to be inspected, and then applicable members for fiberoscope inspection were chosen. After that, relatively vulnerable members were selected and on-site investigations were conducted sequentially. The anticipated problems of the industrial fiberoscope inspection method were examined and the countermeasures were studied. The problems were exactly low rigidity of the fiberoscope cables and difficulty to identify photographing position. The fiberoscope inspection method has been almost established through fiberoscope insertion test and position identification tests on specific inspection members, such as inside of the cable collars at entrance of tower or anchorage, cable saddle, cable anchoring parts of suspension bridges or cable stayed bridges, inside of U-shaped ribs for steel deck, link type bearings and so on.

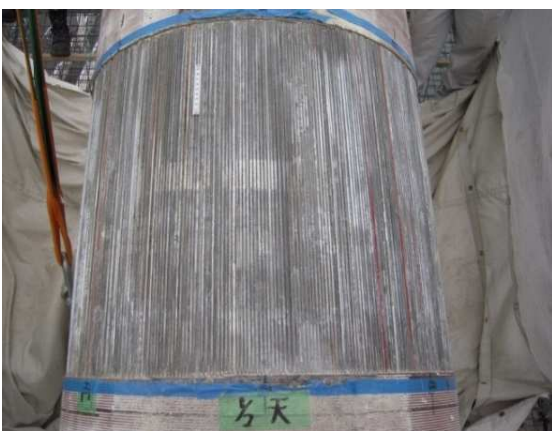
写真-3 ケーブル開放調査の状況
Photo.3 Condition of main cable

レインボーブリッジは、平成5年の供用からおよそ20年が経過し、主ケーブルの塗膜の劣化が顕在化してきました。また、ケーブル内部の劣化についても懸念されたことから開放調査を実施しました。その結果、ケーブル素線の発錆はほとんど見られなかったものの内部が湿潤状態であることが確認されました。このまま放置すると将来的には発錆の懸念があります(写真-3)。

About twenty years has passed since the opening of the Rainbow Bridge in 1993 and the deterioration of its main cables' painting is becoming apparent. The investigation was carried out in order to know the condition inside the main cables. As the result, it was found that the inside was in wet condition but very little corrosion was found. More corrosion in the near future was worried about when this wet condition was left (Photo.3).

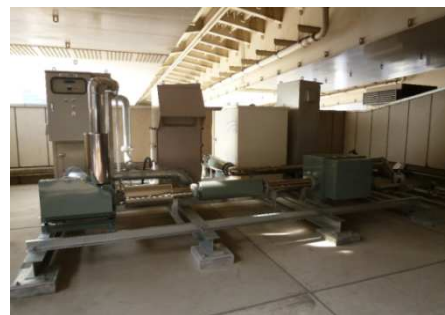
写真-4 乾燥装置
Photo.4 Dehumidifier

送気乾燥システムは、アンカレイジに設置した2基の乾燥装置(写真-4)で主ケーブル全体を分担して乾燥させるシステムとし、送気カバーを12基、排気カバーを6基、新規に設置し、ケーブル内部の相対湿度が40%以下となることを目標として設計しました。また、内部の乾燥状況等をモニタリングするため、モニタリングバンド12基、温湿度計33基を設置する設計にしました。

The system has two dehumidifiers that are set in the anchorages, and covers entire main cables (Photo.4). The target humidity (relative humidity) inside the main cables of the system is below 40 %RH using 12 injection covers and 6 exhaust covers. Moreover, 12 monitoring covers and 33 thermometers are applied in order to monitor the condition inside the main cables.

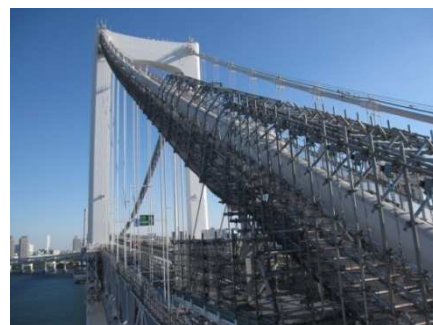
写真-5 工事用足場
Photo.5 Scaffolding

なお、レインボーブリッジでは、主ケーブルの塗装補修工事も平成23年から実施しており、送気乾燥システムの工事についても、足場を共有して実施していません(写真-5)。

The scaffolding for the main cable repainting work, which has been implemented since 2011, is utilized for the system installation work also (Photo.5).

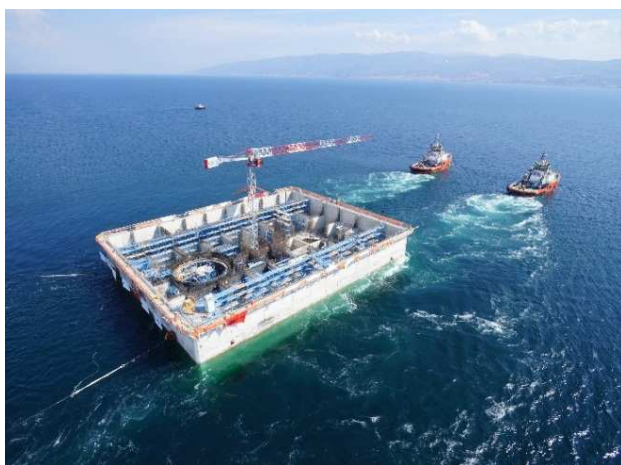
写真-6 ケーソンの曳航
Photo.6 Launching of Caisson Base

2 基の海中主塔基礎が設置される海域では、海底掘削・地盤改良杭の施工が完了し、地震時に免震層として期待される砕石の投入・敷き均しが行われています。地盤改良杭は長さ約 35m 鋼管杭です。195 本/1 基礎の地盤改良杭により、軟弱な地盤の耐震性向上が図られています。砕石層の厚さは約 3m です。鉄筋コンクリート製の主塔基礎はドライドックでの施工が完了し、ウェットドックに曳航された後、内部の隔壁の構築が行われています。工場製作されている鋼製シャフトが主塔基礎上に設置された後、所定の海域に曳航されることになります。

Excavation and driving inclusion piles were completed at the marine area where two caisson bases will be installed. Gravel filling and leveling, which are expected to be a seismic isolation layer, have been ongoing at the said area. The length of an inclusion pile, i.e., a steel pile, for seabed improvement is about 35m. The seismic performance of a tower foundation on soft seabed ground would be improved by 195 inclusion piles a foundation. The thickness of gravel layer is about 3m. The construction work of caisson bases at dry dock was completed. Concreting of the inner walls of the caisson bases has been ongoing at wet dock in Izmit Bay after they were towed from the dry dock to the wet dock. The caisson bases will be towed and placed on the designated positions after steel shafts, which have been fabricated in a factory, are set on the bases.

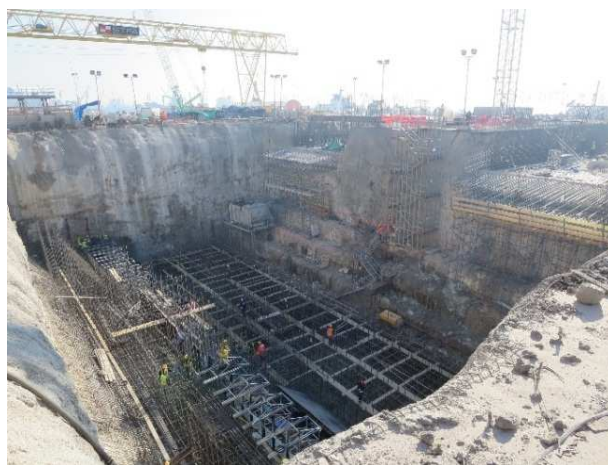
写真-7 北側アンカレイジコンクリート打設
Photo.7 Concreting of North Anchorage

2 基のアンカレイジは、掘削工事が完了し、基礎部へのコンクリート打設が実施されています。北側のアンカレイジは岩盤上に直接定着する形式であり、湧水を伴いながらの岩盤掘削に時間を要しました。支持地盤は亀裂の多い石灰岩です。軟弱な地盤に構築する必要がある南側のアンカレイジでは、地中連続壁が施工された後、内部掘削が行われ、基礎が構築されています。アンカレイジ 2 基の掘削量は約 13 万 m³ に達します。

Excavation work was completed and concrete work has been ongoing for two anchorages. North anchorage is directly placed on rocky bearing layer. It took a long time to excavate the layer with controlling seawater leakage. The bearing layer is lime stone with some cracks. On the other hand, south anchorage is constructed in soft soil condition. Diaphragm wall was constructed before excavation was started. Concreting has been ongoing since the completion of excavation. Excavated volume for both the anchorages amounted to about 130,000m³.
