### 海峡部橋梁マスコンクリート表面被覆要領の改訂

### Revision of Guidelines for Coating of Mass Concrete Structures of Long-Span Bridges

## 白鳥大橋の舗装補修工事 ～鋼床版の健全性維持に向けた舗装打換え～

## テイマー橋のハンガーロープシステムの補修工事

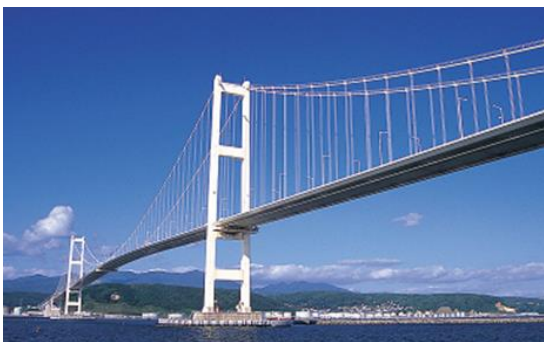
写真-2 白鳥大橋の全景  
Photo 2 Hakuchō-Ohashi Bridge

北海道室蘭市の白鳥大橋は、橋長 1,380m、中央径間長 720m で東日本では最大級の長大吊橋です。本橋は平成 10 年に供用し、15 年が経過した頃から舗装のひび割れが確認されました。そのため、舗装を撤去して鋼床版の調査を行ったところ、局部的な腐食が確認されました。また、目地部においても止水材の劣化部から雨水が浸入していたため、同様の事象が確認されました。そのため鋼床版の防食を目的に防水機能を回復するための舗装打換えを実施し、長期健全性を確保することとし、以下の対応を行いました。

Hakuchō-Ohashi Bridge (Muroran city, Hokkaido) is one of the longest suspension bridges in eastern Japan with center span length of 720m and total length of 1380m. The bridge was opened to traffic in 1998, and fifteen years after opening, cracks were noticed in the bridge pavement. On removal of pavement some local corrosion was found on the steel deck. The same type of corrosion was found on the deck beneath pavement joints due to water penetration through deteriorated sections of joint sealant. In order to preserve long-term bridge performance and to restore the corrosion protection function of pavement system, the following rehabilitation works were implemented :

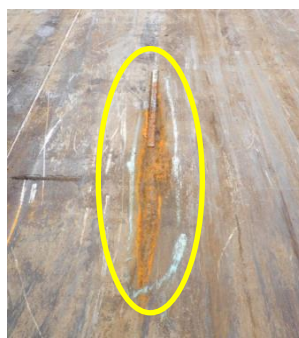
写真-3 点在する鋼床版の局部腐食  
Photo 3 Corrosion on steel deck

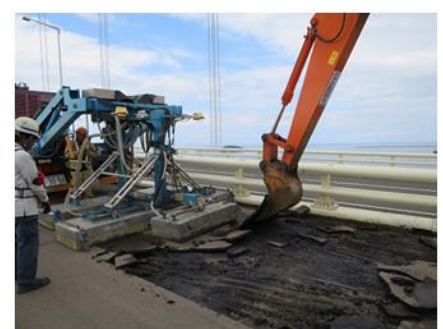
写真-4 IH による舗装撤去  
Photo 4 Pavement removed using IH device

舗装上面から電磁誘導加熱装置によって鋼床版に磁界を発生させることで鋼床版が加熱され、舗装との接着部が軟化し、舗装の撤去が容易になる工法を採用することで、鋼床版の損傷防止と工期短縮を実現

The steel deck was heated by an induction heating (IH) device set up on the pavement surface, softening the pavement and reducing adhesion with the steel deck – the existing pavement was then easily and quickly removed without damaging the steel deck.

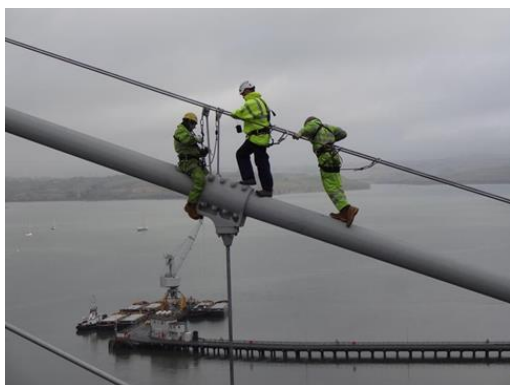
写真-7 定期点検の様子  
Photo 7 Routine inspection

2013 年の定期点検では上側及び下側のケーブルクランプとハンガーソケットのボルトに錆が発生しているのを確認しました。そこで、これら不可視部材においてより詳細な検査を実施することとなり、室内試験のためにいくつかのボルトを外しました。2014、2015 年にはこの追加調査と試験で多くのケースにおいてボルト材料の硬度が当初設計時の上限値を超過することがわかりました。これは、水素脆化によるボルトの脆性破壊の危険性を潜在的に増加させるため、一つの懸念事項でした。

Routine inspection findings in 2013 had identified corrosion on the upper and lower cable clamps and hanger socket bolt assemblies. As a result, more detailed inspections of these hidden elements were carried out and several bolts were removed for laboratory testing. In 2014 and 2015 this additional investigation and testing revealed that in many cases the hardness of the bolt material exceeded the upper limit in the original construction specification. This was a cause for concern because it potentially increased the risk of brittle fracture of the bolts arising from hydrogen embrittlement.

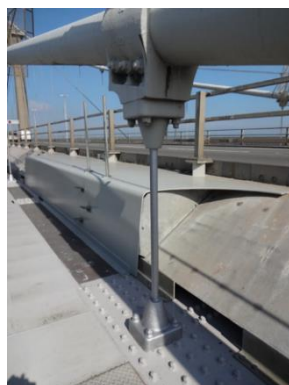
写真-8 ハンガーロープシステム  
Photo 8 Hanger Arrangement

硬度に関するさらに広範囲に及ぶサンプル試験により、さらに不適合であることが明らかとなり、2016 年には、約 1850 個に及ぶ全てのケーブルバンドとハンガーボルトの硬度試験を実施することが決定しました。この試験により全てのボルトのうち約 50%が当初設計時の仕様に適合しないことが判明し、そして、ほぼ全てのハンガー設置箇所ですら少なくとも一つは欠陥ボルトがあるため、全てのボルトに対して交換計画を実施することを決定しました。

Further widespread sample testing for hardness revealed further non-compliances and in 2016 it was decided that every cable band and hanger bolt, approximately 1850 in total, should be tested for hardness. The testing established that nearly 50% of all bolts did not meet the original construction specification and as there was at least one defective bolt at nearly every hanger location it was decided to carry out a full replacement scheme for all bolts.
