## JB 本四高速の活動

### 吊橋センターステイロッドの合理的点検手法

## Activity of HSBE

### Proposing a rational inspection system for the center stay rods of suspension bridges

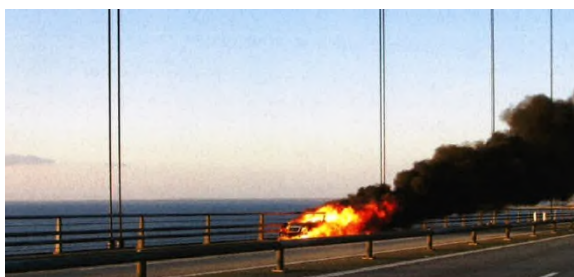
写真-3 橋上で発生した火災（2009年）  
Photo 3 Car on fire in 2009

デンマークのフン島とシェラン島とを結ぶ、グレートベルト・イースト橋は、これまでに約40件（2004年以降の集計）の乗用車やトラックの火災を経験しています。幸いにもこれらの火災は、ハンガーロープ近くで発生した1件の火災を除いては、いずれもメインケーブルから離れた場所で発生したものです（写真-3）。一方、フン島の西部に架かるリトルベルト橋では、2013年に中央径間中央付近のメインケーブル付近で火災が発生しました。このリトルベルト橋での火災、最近の交通量の増加及び新たなリスク予測といった観点を踏まえて、ストアベルト社は、グレートベルト・イースト橋のメインケーブルの路面に近い下側の範囲に対して、防火対策を施すことにしました。

Since 2004, the Great Belt Bridge has been exposed to approx. 40 fires in cars and trucks. Fortunately, none of the fires were near to the main cables, and only one small fire was close to the hangers (Photo 3 from 2009). On the Little Belt Bridge, there was a fire in 2013 and the fire was close to the central node area. Due to the fire on Little Belt Bridge, increased traffic and new risk calculations, A/S Storebælt decided to install fire protection on the lower part of the main cables on the Great Belt Bridge.

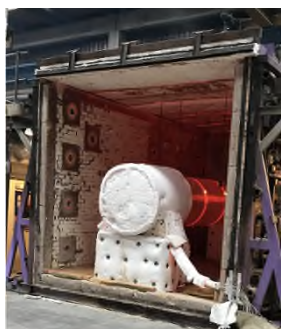
写真-4 ケーブル耐火試験  
Photo 4 Fire test in 2018

防火対策は、路面から17mまでの高さに対して設置され、メインケーブルが炭化水素火災（セ氏1100度）を受けた場合に、ケーブル表面を高温から保護（55分間にわたってセ氏400度以下に抑えられることを目標）するよう設計されました。事前に防火対策の効果を確認するため、2018年に、3種類の異なる防火対策を施した5mの長さの鋼管を対象に試験を実施しました（写真-4）。

The protection reaches from road level up to 17m above road level. The protection is designed to prevent high temperatures on the surface of the main cables (target is to keep temperatures below 400 degree Celsius for 55min) if exposed to a hydro carbon fire (1100 degrees). In 2018, fire testing was conducted on a 5m long steel pipe insulated with three different systems of protection to confirm the effect of each system (Photo 4).

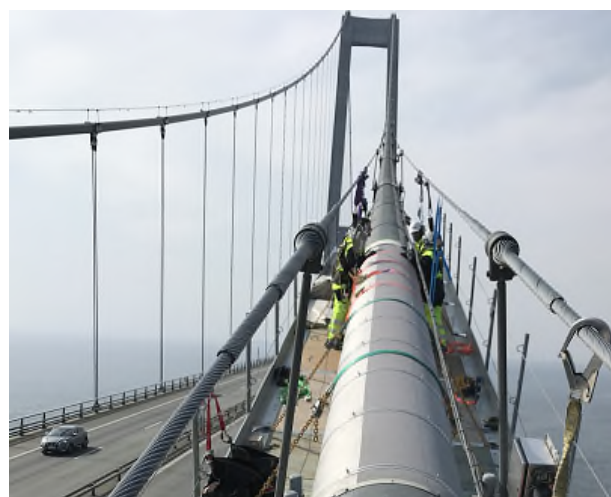
写真-5 防火対策の設置（2019年）  
Photo 5 Fire protection work in 2019

現在、総延長が約1200mの防火対策の設置工事を実施中で、2019年内には設置を完了する見込みです（写真-5）。また、防火対策を施す範囲のケーブルバンドには、特殊な耐火仕様の塗装が施されますが、その仕様は、2018年に実施された様々な塗装仕様を対象にした試験により設定されました。

The installation work is ongoing and expected to finish in 2019. The total insulated length is approx. 1200m (Photo 5). In the same area, the cable clamps will be painted with a special fire protective coating. In 2018, tests were performed with different paint systems.
