JB 本四高速の活動

海峡部橋梁路面上の強風特性調査

若戸大橋の現況

トルコ第一ボスポラス橋 主ケーブル開放調査と塔頂主ケーブル補強

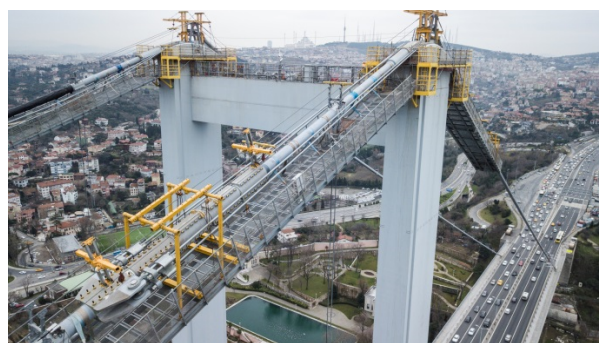
写真-3 主ケーブル補強施工状況

Photo-3 Photo of main cable strengthening

主ケーブルの断面欠損を補うため4本の補強ストランドを追加し、既存主ケーブルの張力の一部を受け持たせる構造が採用されました。補強ストランドにはφ92mmのロックドコイルロープが使用され、ジャッキを用い4本合計で12,000kNの張力が導入されました。これは主ケーブル断面の約一割に相当する張力となります。主塔の中央径間側・側径間側で素線が損傷していたため、図-5に示すように主塔を跨ぐように補強ストランドを配置し、新しく主ケーブルに取り付けたケーブルバンドに定着されています。

Four additional strands were added at each location in order to compensate for the loss of a number of broken wires. 92 mm diameter full locked coil strands were adopted as the additional strands. The strand tension, totalling 12,000kN for the four strands, was introduced by a jacking system. This equates to almost 10% of the main cable sectional force. Since severe corrosion and broken wires were observed on both sides of the towers as shown in Figure 5, additional strands are connected to a series of cable bands which act as anchor points of the new strands beyond the damaged sections of the main cable.

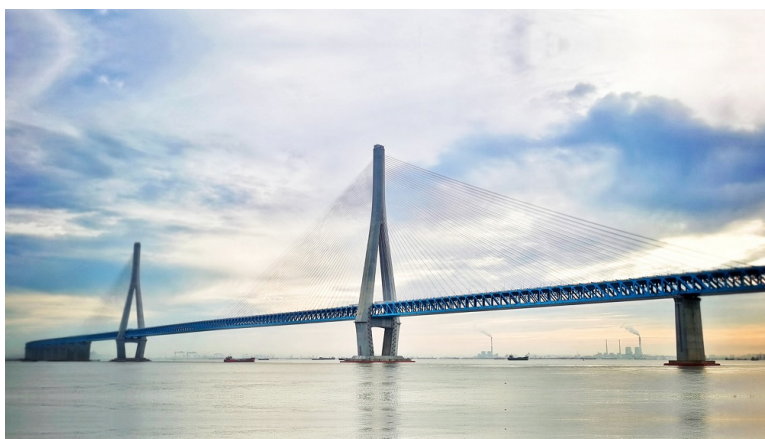
写真-4 滬蘇通長江公鉄大橋

Photo-4 Shanghai-Suzhou-Nantong Yangtze River Bridge

滬蘇通長江公鉄大橋は、道路鉄道併用の斜張橋としては、世界最長の橋になります。主塔はコンクリート製で高さ 325m、斜材は 3 面吊りで全部で 432 本あり、最も長い斜材は、長さ 576m で重さは 83.5 トンになります。トラス桁の幅は 36m、高さは 16m で、上層に 6 車線（片側 3 車線）の道路、下層に鉄道が設置されています。開通に先立ち、橋が設計どおりの挙動を示すかどうかを確認することを目的に実橋で載荷試験が行われました。

The bridge is the longest cable-stayed road-rail bridge in the world. The concrete tower is 325 m high, and cables are arranged in three planes. There are 432 stay cables in total, the longest being 576 m and weighing 83.5 tonnes. The girder is composed of a truss, which is 36 m wide and 16 m deep. It carries six lanes of traffic on the upper level with three in each direction, and the lower level carries the rail traffic. Before the bridge was opened, a proof load test was carried out to see if the bridge behaved as designed.
