JB 本四高速の活動

AI 技術を活用したハンガーロープ画像診断技術

Activity of HSBE

AI-based diagnostic imaging for suspender ropes

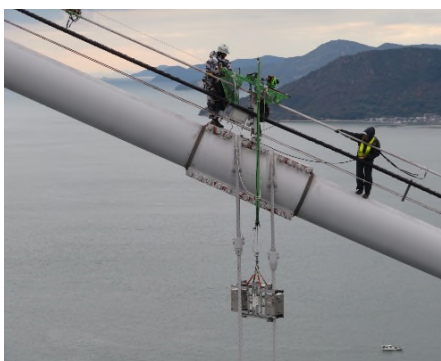
写真-1 北備讃瀬戸大橋の調査
Photo-1 Test in the Kita Bisan-Seto Bridge

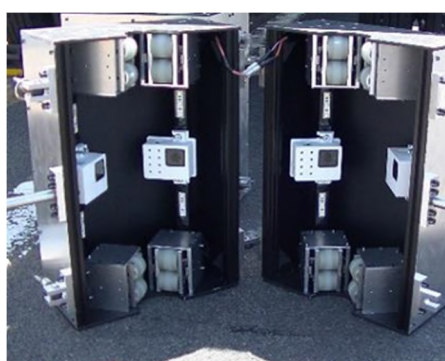
ハンガーロープ全長全周の変状確認は、目視するにしても、カメラ撮影するにしても、位置等の制約から容易ではありません。そこで、JB 本四高速グループの(株)ブリッジ・エンジニアリングにおいて、ハンガーロープ画像診断システムの開発に取り組んでいます。これは、複数のカメラを搭載した容器(写真-2)をハンガーロープに取付け、昇降させることにより、高精細の近接画像を取得するものです。AI 技術でその画像を診断することにより、変状種別分類(塗膜割れ、剥がれ、発錆等)を効率的に行います。画像診断には均質で明瞭な画像が必要となります。そこで、太陽光等、外部の影響を排除するため、遮光性を保てる容器内に 4 台のカメラを格納し、LED 照明により照度を確保して、全周を同時に撮影しています。AI 技術により取得画像を変状分類した北備讃瀬戸大橋ハンガーロープ表面の例を写真-3 に示します。

写真-2 カメラ容器(内部)
Photo-2 Image acquisition module

It is difficult to detect deterioration in suspender ropes throughout their entire length and circumference by close visual or camera-based inspection because of access constraints. Bridge Engineering Co.,Ltd., a group company of HSBE, is currently working on the development of a diagnostic imaging system for suspender rope inspections. The imaging system consists of the image acquisition module equipped with multiple cameras. The module is attached to the suspender rope, and high resolution images of the surface of the suspender rope are acquired throughout its entire length. Using AI-based image processing, the detected deterioration is efficiently categorized into typical deterioration categories such as paint cracking, peeling and rust. The AI-based diagnostic imaging requires homogeneous and clear images, and to eliminate the effect of sunlight and other environmental factors, the image acquisition module with its four cameras is placed in a lightproof box, and images are taken simultaneously throughout the whole circumference securing the desired level of light intensity using LED lighting. An example of an acquired image of a suspender rope of the Kita Bisan-Seto Bridge is shown in Photo-3.

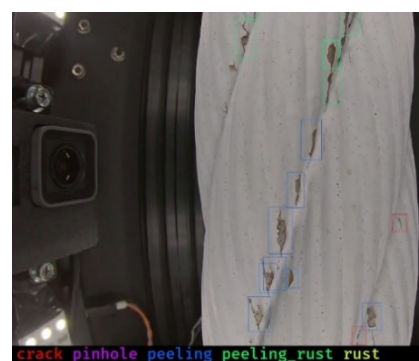
写真-3 画像 AI 診断状況
Photo-3 AI-based diagnostic imaging

Camera location data is embedded in the acquired images, and by analyzing the accumulated images of specific locations, the progress of long-term deterioration is objectively monitored, and the accumulated data serves as the basic data for deterioration prediction. Unlike manual image processing by inspectors, the AI-based processing enables efficient diagnosis for suspender ropes with practical processing speeds and improves consistency by eliminating human error or variations in judgement.

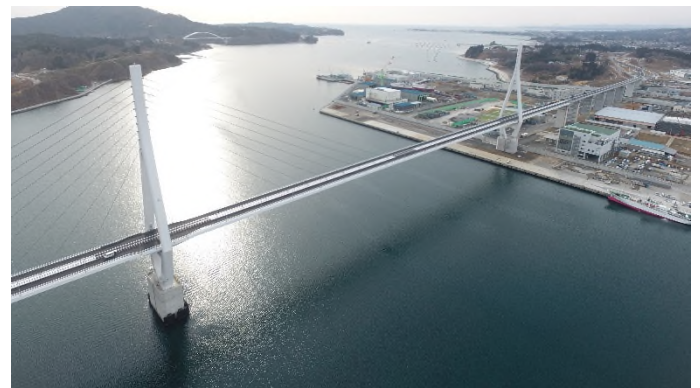
写真-5 気仙沼湾横断橋全景

Photo-5 Kesennuma Bay Crossing Bridge

気仙沼湾横断橋は全長 1,344m で、陸上部 664m 及び海上部（斜張橋部）680m から構成されます。このうち斜張橋部は、支間長 360m の3 径間連続鋼斜張橋です。

The Kesennuma Bay Crossing Bridge has a total length of 1,344m, and comprises a 680m long cable stayed bridge and a 644m long viaduct. The cable stayed bridge is a three-span continuous steel bridge with a main span length of 360m.

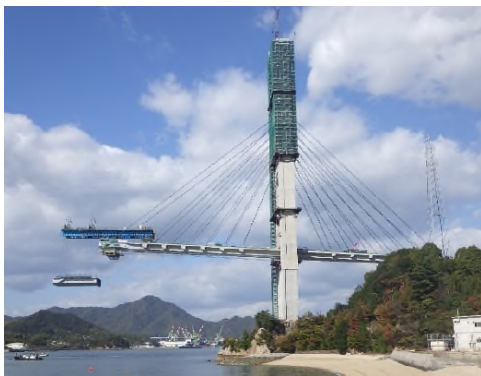
工事は、岩城島側と生名島側とで分割して別業者が施工しており、令和元年9月より、主塔からのPC桁の張出し架設が開始され、さらに令和2年10月からは、鋼桁の架設が開始しております。10月12日にはFC船により生名島側中央径間の鋼桁第1ブロックの架設が行われました。第2ブロック目以降の鋼桁については、桁上に設置されたエレクションノーズと呼ばれる架設桁により行われ、エレクションノーズの上部に設置された4基のジャッキから吊り下げた4本の鋼ケーブルと鋼桁ブロックとを接続し、吊上げ架設が行われます。

写真-6 鋼桁架設の様子
Photo-6 Steel girder erection

The construction has been progressing on both the Iwagi and the Ikina sides of the crossing, and cantilever erection of PC (pre-stressed concrete) girder started in September 2019, and steel girder erection started in October 2020. On October 12th, the first steel box girder segment in the Ikina side in the center span was lifted into place by floating crane. After installation of the second girder segment, the subsequent girder segments have been installed using a temporary erection beam (called an "erection nose") placed on the leading end of the girder. Girder segments are connected to 4 hydraulic jacks mounted on the erection nose using steel wires, and lifted into position.

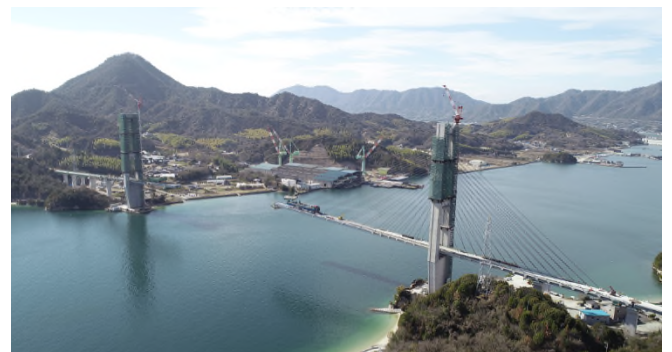
写真-7 岩城橋全景
Photo-7 Iwagi Bridge

本橋は、橋長735mの5径間連続鋼・コンクリート混合斜張橋で、主塔はコンクリート製で、高さが130mを超える国内でも最大級の構造です。

The bridge is a five-span continuous steel-concrete hybrid cable-stayed bridge with a total length of 735m, and the concrete main towers are over 130m high and amongst the tallest bridge towers in Japan.

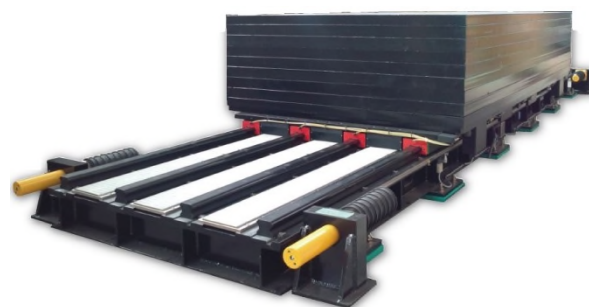
AMDは主塔の渦励振による振動を抑える目的で設置されており、海面から約170m(主塔高さの70%)の主塔内部にあります。主塔内の設置場所に限りがあることから、小型で軽量なリニアモーター型のAMDが採用されています。AMDは主塔の加速度を常時観測し、5gal以上の揺れを観測すると自動的に稼働を開始し指定の加速度を下回るまで制振を行う設定となっています。

写真-9 リニアモーター型 AMD
Photo-9 Linear motor Active Mass Damper

The AMDs are installed inside the tower legs at +170m in elevation (70% of total height) in order to mitigate vortex-induced vibration in the tower legs efficiently. Linear motor type dampers were chosen for their light weight and compact dimension to fit within the limited spaces inside the towers. The AMDs contain accelerometers to monitor the movement of the towers and will be automatically activated when the acceleration exceeds a 5 gal (0.05m/s²) threshold.

The purpose of the performance test was to check that the damping ratio of the tower combining the structural damping and the additional damping by the AMD fulfills the design requirements, as otherwise the parameter setting should be adjusted. In the test, AMDs were first activated manually to excite the movement of the tower in the first out-of-plane bending mode. Then, the structural damping was measured during free vibration and confirmed that the structural damping of the tower had not changed from the time of bridge completion. Lastly, the additional damping was measured by activating the AMD after the forced vibration as detailed above. In conclusion, it was confirmed that the performance of the AMDs in mitigating vortex-induced vibration complies with the design requirement.
