JB 本四高速情報

因島大橋の耐震補強設計

Activity of HSBE

Seismic retrofit design of Innoshima Bridge

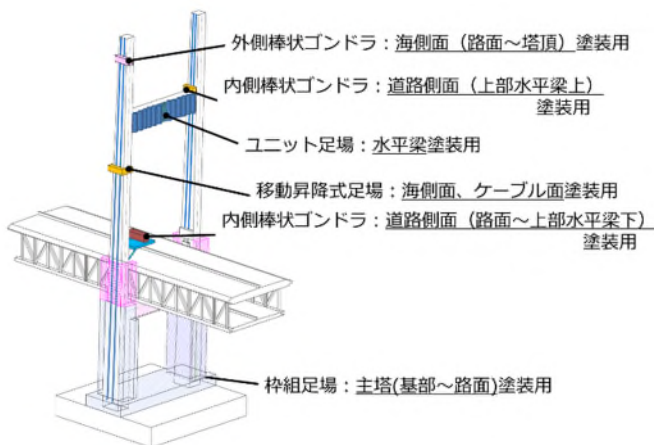
図-2 主塔塗替塗装工事足場概要図

Fig.2 Scaffoldings for Repainting of Main Tower

足場は、枠組足場、吊足場、ゴンドラ及び移動昇降式足場等を用いて施工を行いました。主塔基部のフーチング上から補剛トラス下までは枠組足場を設置し、下部水平梁は吊足場を設置し施工をしました。道路面より上の主塔外側（海側）及び主塔内側（道路側）は、それぞれ既設ガイドレールを利用したゴンドラを設置し施工を行いました。

主塔橋軸面側（ケーブル面側）は、既設のガイドレールが無い場合、マンションやビルの修繕工事でも使用されている移動昇降式足場（リフトクライマー）を用いて施工を行いました。リフトクライマーは、足場デッキ部からスライドデッキを張り出すことができる構造であるため、主塔外側のガイドレールにマストを設置し、ケーブル面側の施工を行いました。

上部水平梁は本工事に設計・製作したユニット足場を架設して施工を行いました。本ユニット足場は13分割しており、1基ずつ架設・横移動して固定し、一体化することで、首都高速湾岸線を通行止めすることなく設置・撤去を行うことができました。

Repainting work was carried out using framed scaffolding, suspended scaffolding, gondolas, and mobile scaffolding. Framed scaffolding was installed from the footing at the base of the main tower to the bottom of the stiffening truss, and suspended scaffolding was installed for the lower horizontal beam. The outside (seaward side) and inside (roadside) of the main tower above the road surface were repainted with gondolas using the existing guide rails.

Since there were no existing guide rails on the bridge axis side of the main tower (cable side), the mobile scaffolds (lift climbers) were used that are also used for repair work on condominiums and buildings. Since the lift climber has a structure that allows the slide deck to be extended from the scaffold deck section, the cable side was repainted with masts installed on the guide rails on the outside of the main tower.

The upper horizontal beam was repainted with a unit scaffold designed and fabricated for this project. This unit scaffold was divided into 13 sections. Each section was erected, moved horizontally, fixed, and integrated into a single unit. The construction process enabled the installation and removal of the unit scaffold without closing the Metropolitan Expressway Bayshore Route.

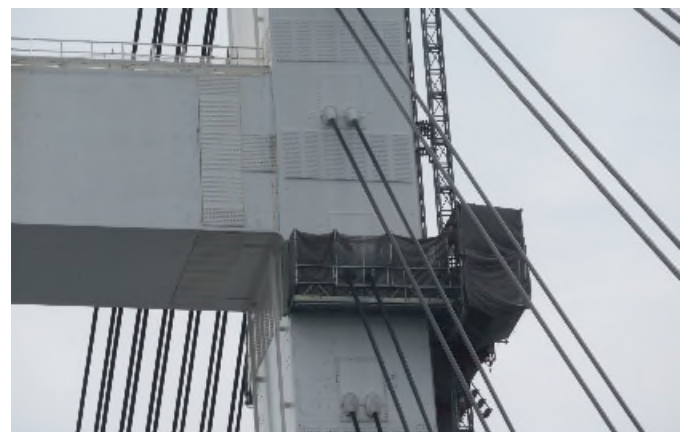
写真-2 移動昇降式足場（リフトクライマー）

Photo-2 Mobile scaffolding

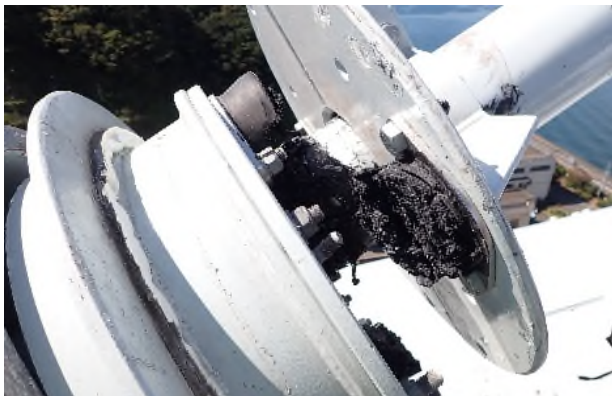
写真-3 制振ダンパー破断状況
Photo 3 Rupture of Rubber Damper

このため、2019年に全数点検を実施し、104本のケーブルのうち86本にダンパー損傷が見られ、そのうち8本がダンパー破断、12本にケーブルの接触痕がありました。その都度、制振ゴムダンパーの取替えなど行ってきましたが、その後も損傷が続き、2021年から対策検討に着手し、2022年に52本のケーブルの応急対策を実施しました。2023年にも残り52本のケーブルの応急対策を実施します。

制振ゴムダンパー設置部の構造は、ケーブルが振動する際、ゴムダンパーがケーブル本体を弾性的に拘束し、減衰させることで振動を抑制している仕組みです。しかし、なんらかの要因でケーブル本体が大きく振動し、ケーブル端部での振動振幅が制振ゴムダンパーの許容範囲を超えることで、ボルト部への接触などによる損傷や破断につながっています。

Therefore, 104 cables in total were inspected in 2019 and damaged dampers were observed on 86 cables. And 8 dampers were broken and 12 dampers had cable contact scratches. Although the damaged dampers were replaced each time, damaged dampers have been observed continuously. Countermeasures of these damage was discussed since 2021 and emergency countermeasures were conducted for 52 cables in 2022. In 2023, the same countermeasures will be conducted for remaining 52 cables.

However, when the cable vibrated significantly for some reason and the vibration amplitude at the cable end exceeded the tolerance range, it leads to damage or rupture due to contact with the bolt.

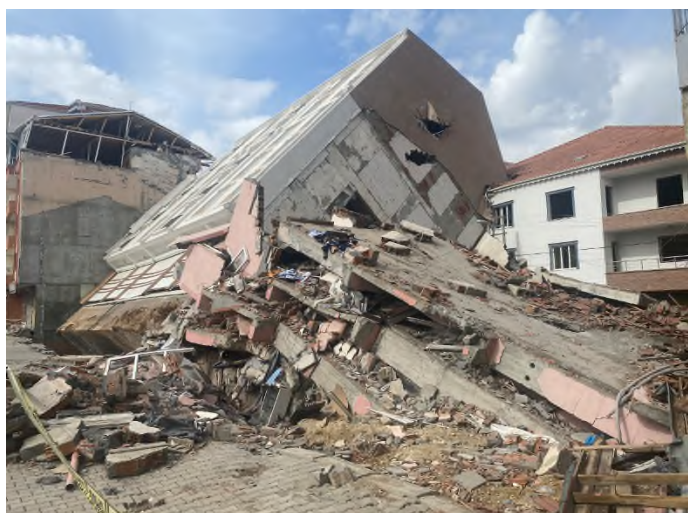
写真-4 崩壊した住宅建築 (Adiyaman)
Photo 4 Collapsed Residential Buildings in Adiyaman

建築物の被害が甚大でした。トルコの一般的な住宅建築としては、RC造の柱と梁の骨組みに、レンガや石積みのブロックからなる壁を組み合わせたものです。このような建物は耐震設計が考慮されていないため、パンケーキクラッシュのような全体崩落が発生し（写真-4）、多くの命が失われました。

The damage on buildings were extensive. The typical building type in Turkey for residential structures is a reinforced concrete frame of columns and girders with infill walls, made from bricks or masonry blocks. The lack of seismic design of these structures caused total collapse in a pan-cake style which was the primary cause of the extensive life loss as seen in an example illustrated in Photo 4.

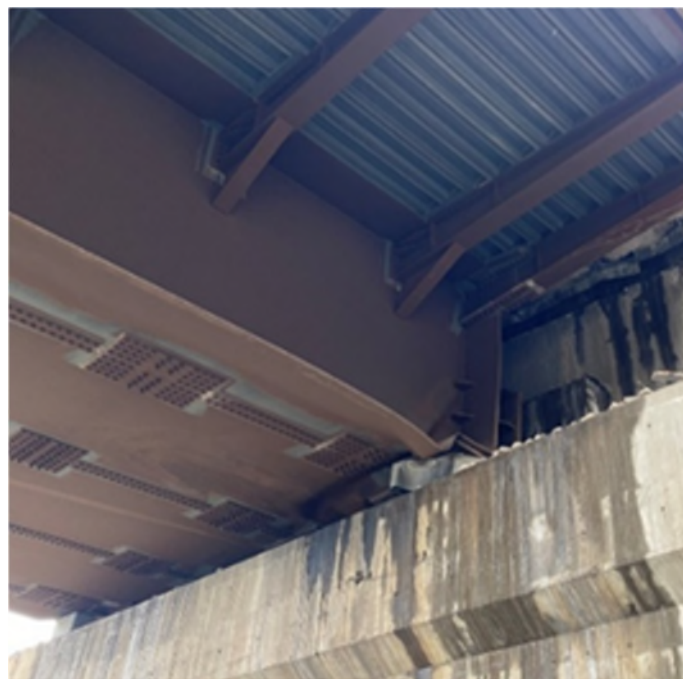
写真-6 箱桁端部の損傷
Photo 6 Box girder damage at bridge end.

一方、道路橋梁の方はよく持ちこたえました。地震後の2023年3月7日～3月10日の間、IHIのエンジニアたちは現場踏査を行い、被災地における橋梁の状態を点検しました。今回の点検で注目したのは、最初の地震の震源地からわずか50kmに位置するNurdag市付近のTarsus-Adana-Gaziantep高速道路の山岳道路上の高架橋群です。点検したNurdag市付近の橋梁は全て鉄筋コンクリートの橋脚を有し、上部構造が鋼製箱桁またはプレキャストPC桁で構成されています。点検の結果として、橋梁の損傷は端部に限られており、伸縮装置と粘性ダンパーに集中していることが確認されました。ほとんどの伸縮装置が損傷していることが確認されましたが、これはこの規模の地震であれば想定されることです。橋梁の下部構造については、ほとんどの橋梁で少しひび割れが見られたことをのぞき良く持ちこたえましたが、そのうち1つの橋梁の一对の橋脚で明らかな座屈損傷が確認されました（写真-5）。また、当該橋梁は地震中に橋軸方向に大きな変位が生じ、橋台と上部構造が衝突したため、端部に激しい座屈が発生しました（写真-6）。

While the residential buildings showed a very poor performance the bridges of the road infrastructure can be said to have acted soundly. After the earthquake IHI engineers organized a field tour between March 7th and March 10th, 2023, to examine the structural conditions of the bridges in the disaster hit region. The main focus of the inspection was the bridges on Tarsus-Adana-Gaziantep motorway where there are various viaducts on the mountain passage near city of Nurdag which is only 50 km far from the epicenter of the first earthquake. All of the inspected bridges near Nurdag have reinforced concrete piers where the superstructures are either of steel box type or prestressed precast concrete girder type. It was observed that the damage on the bridges are limited to the bridge ends and concentrated on bearing expansion joints and viscous dampers. Majority of the expansion joints were observed to be damaged which is very natural for an earthquake of this intensity. Substructures of the inspected bridges seemed to have behaved well, except a few cracks on majority of the bridges, but one of the bridges had a pair of piers with apparent buckling damages (Photo 5). This particular bridge had also experienced severe buckling at the end girder due to pounding of the bridge superstructure to the abutment (Photo 6). It seems that severe longitudinal movement occurred during the earthquake caused this damage.

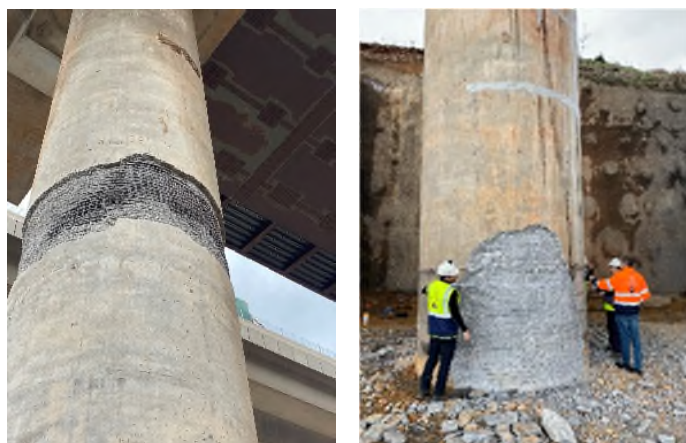
写真-5 橋脚の局部座屈
Photo 5 Pier damage due to local buckling
