JB 本四高速情報

近赤外線ハイパースペクトルイメージングによる 上塗塗膜の損耗状況の計測

Activity of HSBE

明石海峡大橋主塔下部水平材連絡用マンホール拡大工事

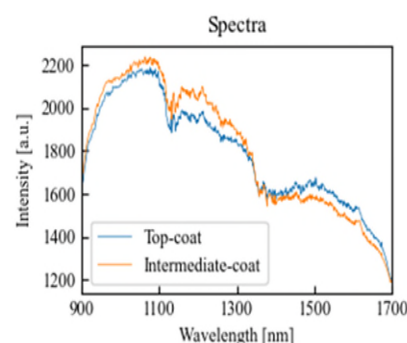
図-2 実橋で計測した上塗と中塗のスペクトル
Fig.2 Spectra obtained for top and intermediate coat

現在神戸大学との共同研究では、近赤外線を活用した重防食塗装の劣化検知について取り組んでいます。これは、塗膜に使用される材料によって近赤外領域における分光特性が異なることを利用して上塗りの損耗や中塗りの露出状況の検出を遠隔・非破壊で行うものです。昨年度は、分光特性が未知である実橋の塗膜に対してハイパースペクトルイメージングシステムによる現地計測を行いました。このシステムによる計測の結果、現場で分光計測をすることができ、中塗り露出を検出するための最適な計測波長を現場で把握することがわかりました（写真-1、図-2）。

HSBE is currently working on a joint research project with Kobe University to detect the deterioration of heavy-duty anticorrosion coatings using near-infrared measurement. This is to detect the deterioration of the top coat and the exposure of the intermediate coat non-destructively and remotely by utilizing the different spectral characteristics of materials in the near-infrared region. In the last year, measurements using a hyperspectral imaging system are conducted on coatings whose spectral characteristics were unknown on actual bridges. The results of measurements with this system show that spectral measurements can be made, and the optimum measurement wavelength to detect the exposure of the intermediate coat can be found on site. (Photo 1, Fig.2)

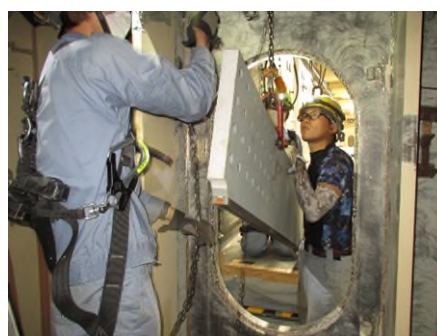
写真-2 補強部材建て起こし状況
Photo 2 Installation of reinforcement

工事に先立ち、MH 拡大に伴う補強構造及び施工時の安全性の解析的検討を行いました。本検討では、過年度に行った耐震性能照査時の 3 次元モデルを活用し、弾塑性有限変位解析による構造全体での照査を行いました。MH 拡大に伴う断面欠損を補う補強構造は、FEM 解析により検討しており、MH 拡大部及びその周辺部材については、FEM シェル要素によりモデル化することで、MH 拡大前後の Von Mises 応力変動が、MH 周辺のみであり、吊橋主塔設計要領・同解説に示される降伏点強度の 0.8 倍以内であることを確認しました。また、MH 拡大後の主塔全体への影響照査のため、前述の補強構造モデルに対して活荷重条件と風荷重条件で荷重漸増による耐力解析を行い、両荷重条件において、施工前後で耐力曲線に差はなく、詳細設計時の解析結果とほぼ一致することを確認しました。さらに、解析結果の妥当性を確認するため、6 分の 1 縮小模型供試体による耐力試験を行い、得られた結果を用いて実橋施工パネル部の耐力検証を解析的に行った結果、MH 拡大による耐力の低下は見られないことを確認しました。施工箇所は、主塔内部の狭隘な空間であることから、原寸大模型を作成し、補強部材の建て起こしや溶接時の予熱方法等の施工性についても確認しています。

The analytic study was carried out to check the reinforced structure for the enlargement manhole and the safety during the work. In this study, the strength of the entire structure was checked by the elasto-plastic and finite displacement analysis using 3D model created in the past study. The reinforced structure for the reduced sectional area was considered by FEM analysis. The enlarged manhole section was modelled by the FEM shell element and, it was found that the Von Mises stress was changed only around the manhole and was within 0.8 times the yield strength before and after the enlargement work. In order to check the effect of the enlargement work on the main tower, the ultimate strength analysis with load incremental method under the live and wind load conditions was carried out using the FEM shell model. As a result, it was found that no difference in the ultimate strength curves before and after work, and that the strength after work was about the same as the previous detailed design. It was checked the result of the analysis was valid from the ultimate strength test using one-sixth scaled model, and there was no decrease in strength due to work from the ultimate strength analysis of the full-scaled panel using the result of one-sixth scaled model test. Because the inside of the tower is very narrow, the workability was considered, in which the member for reinforcing were brought and set, and in which the enlarged manhole section was preheated before welding.

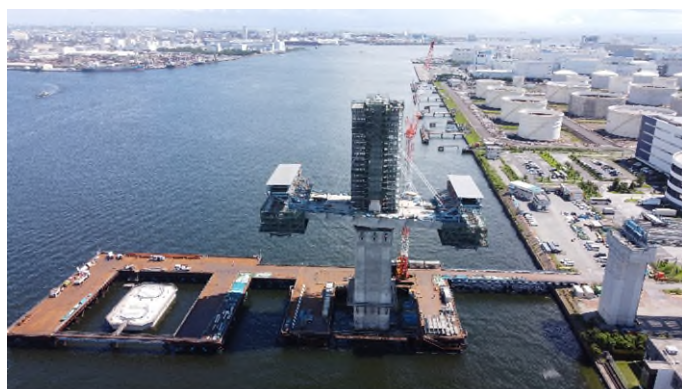
写真-3 ピロン柱・仮斜材を用いた張出施工状況（図-4イメージ図と反転）

Photo 3 Cantilever erection using temporary pylon and cables
(reversed from Fig. 4 image)

このピロン柱及び仮斜材は完成時には不要となる仮設物ですが、中央径間部鋼桁の張出し架設と本斜材設置の施工を進める中で、適宜ピロン柱からの仮斜材の張力調整等を行う必要があり、撤去時においても施工管理が重要となります。現在、側径間部ではピロン柱と仮斜材を用いてPC桁の張出し施工しているところであり早期供用を目指して引き続き施工を進めていきます。

Although the temporary cables and pylons are not necessary at the completion of the bridge, adjustment of tensile force of the cables is necessary with the progress of the erection of steel girders in the central span and cable. In addition, execution management is also important in removing these temporary members. At present, PC girders are being expanded using these temporary cables and pylons, and construction will continue with the aim of early service. (This information was provided by Keihin Port office, Kanto Regional Development Bureau, MLIT.)

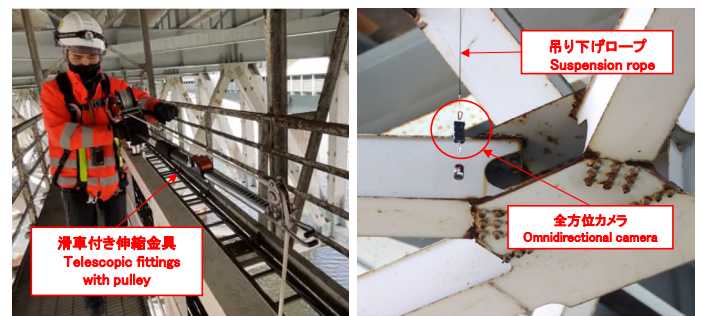
写真-5 全方位カメラ昇降点検システム

Photo 5 Omnidirectional camera elevation inspection system

対傾構下弦材の格点部は、特殊高所技術でなければ接近できません。そこで、全方位カメラを任意の高さに昇降できる装置を開発し、対傾構下弦材格点部の点検に活用しています。この装置は、360°撮影のできるカメラを専用の滑車付き伸縮金具先端に取り付けたものであり、近接目視に代替えできる技術として開発したものです。

The lattice points of the sway bracing lower chords can only be approached using special elevation techniques. Therefore, a device that allows the omnidirectional camera to be raised and lowered to any height was developed, and it is used to inspection of the lattice points of the lower string members of the sway bracing. This device consists of a 360° camera attached to the end of a telescopic metal fixture with a special pulley, and was developed as a technology that can replace the close-up visual inspection.

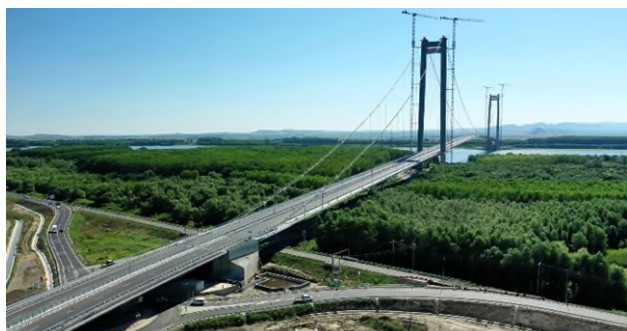
写真-6 吊橋全景
Photo 6 Bridge overview

Construction of the suspension bridge has now completed in Braila, in the eastern part of Romania. As previously introduced in Newsletter No. 73 (July 2018), No. 83 (January 2021) and No. 87 (February 2022), the construction of the bridge was started in December 2018, and 5 years later, on July 6th, 2023, the opening ceremony was held for 11 km long national road including the suspension bridge, and it was opened to traffic in the evening of the same day.

Prior to the opening to traffic, in June 2023, a series of the load tests was conducted on the bridge to confirm the appropriateness of the design and the construction.
