JB 本四高速情報

大島大橋での主ケーブル外装点検システムの実証試験

Demonstration test of the main cable exterior inspection system in Ohshima Bridge

平戸大橋における床組縦桁連続化の構造検討

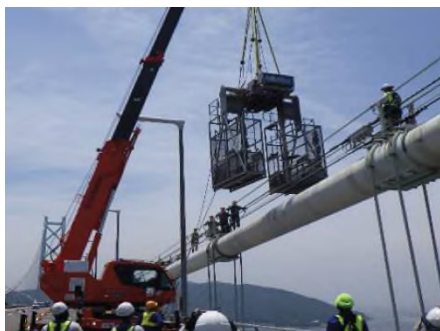
写真-1 ケーブル作業車架設状況

Photo 1 Installation of cable maintenance vehicle

主ケーブルは、吊橋にとって非常に重要な部材の一つであり、ケーブル送気乾燥システムの導入により、健全性の確保に努めています。仮にケーブル外装に施している塗装に割れ等の損傷が生じると、乾燥空気の漏れや水分の侵入によって防食性能が低下することとなるため、点検による早期発見が必要となります。主ケーブルの点検には、通常、ケーブル作業車を用いて行いますが、それには車線規制を行い、ラフタークレーンを用いてケーブル作業車をケーブル上に架設する必要があります（写真1）。また、ケーブル作業車は、ケーブル補修工事で多くの日数を使用するため、点検で使用できる日数が限られています。これら課題の解決に向け、ケーブル作業車を必要とせず、ケーブル上に人力で設置が可能な主ケーブル外装点検装置の開発が求められました。主ケーブル外装点検装置は、小型軽量の台車上にカメラ制御PCと電源ユニットを設置し、台車からは門型に主ケーブルを囲む形でカメラを配置しました（写真2）。

Inspections of main cables are usually performed using cable maintenance vehicle, which must be mounted on the cables by means of lane restrictions and a crane (Photo 1). Since cable maintenance vehicles are extensively used for cable repair work, the number of days they can be used for inspections has been limited.

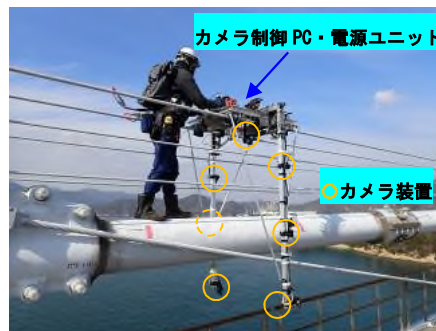
写真-2 大島大橋中央 傾斜角 8° 未満

Photo 2 Center of Ohshima Bridge: inclination less than 8 degrees

The main cable exterior inspection system consists of a camera control PC and power supply unit on a compact and lightweight cart, and cameras are aligned on a portal frame surrounding the main cable. (Photo 2)

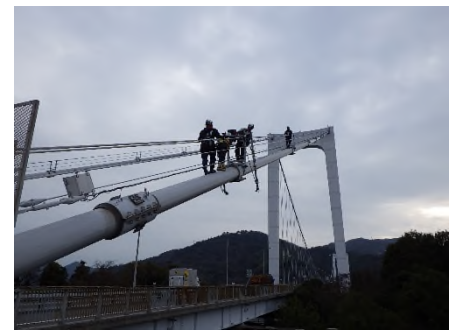
写真-3 大島大橋側径間 傾斜角 24°

Photo 3 Side span of Ohshima Bridge: inclination of 24 degrees

2022年度に試作品での屋内試験を開始し、2023年度に大島大橋実橋にて、屋外で使用可能な試作品による実証試験を行いました。その結果、主ケーブルの傾斜が通常傾斜（8°未満）の場合、急傾斜（24°）の場合ともに、主ケーブル全周を7つのカメラで連続撮影し、その画像による点検が可能であることを確認しました（写真3）。

In 2022 lab test with a prototype started, and in 2023 verification test with another prototype that can be used outdoors was conducted on the Ohshima Bridge. As a result, it was confirmed that the entire circumference of the main cable can be inspected using images taken continuously by seven cameras at both normal (< 8 degrees) and steep (24 degrees) inclinations of the main cable. (Photo 3)

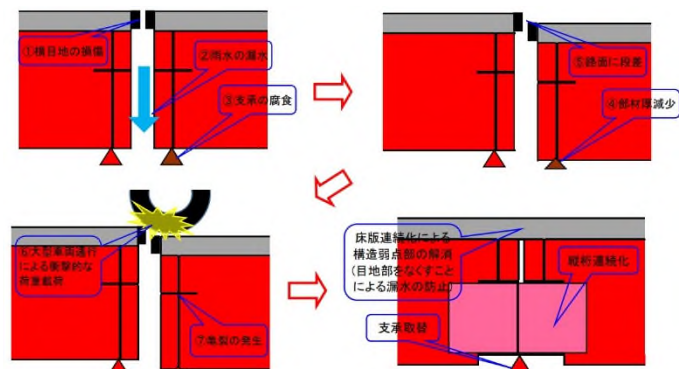
図-1 損傷発生および補修対策のイメージ図
Figure 1 Damages and repairs

平戸大橋は、長崎県が管理する単径間 2 ヒンジ補剛トラス吊橋(最大支間長 465.4m)です。本橋の床組は、単径間、3 径間、4 径間のブロックの組み合わせであり、ブロック間は掛違い部として横目地(伸縮装置)が存在しています。この横目地からの雨水の漏水や厳しい塩害環境下で支承の腐食が進行し部材厚が減少したため、路面に段差が生じ、段差部を大型車両が通過することで衝撃的な荷重载荷が繰返し作用したことから、縦桁支点上補剛材と横桁下フランジとの溶接部に亀裂が生じています。横目地部は構造上の弱点であるため、補修対策として、将来の維持管理性を考慮し、支承の取替と併せて構造上の弱点を解消するため、床組縦桁連続化の構造検討を実施しました。

The Hirado Bridge is a single-span, two-hinged stiffened truss suspension bridge with a maximum span length of 465.4 meters, managed by Nagasaki Prefecture. The bridge's floor system consists of a combination of single-span, three-span, and four-span blocks, with transverse joints (expansion devices) at the intersections between these blocks. Due to rainwater leakage from these joints and the progression of corrosion in the severe salt-damage environment, the thickness of the bearing members has decreased. This has resulted in unevenness on the road surface, leading to repeated impact loads when large vehicles pass over these sections. Consequently, cracks have developed in the welds between the vertical stiffeners and horizontal stiffeners. Since the transverse joints are structural weaknesses, we conducted a structural examination of continuous floor framing girders to address these weaknesses, along with the replacement of the bearings, considering future maintainability as part of the repairs.
