JB 本四高速の活動

瀬戸大橋 30 周年、明石海峡大橋 20 周年

<u>瀬戸大橋吊橋のグレーチング閉塞に伴う</u> 耐風安定性検討

<u>Aerodynamic Stability Evaluation for Seto-Ohashi</u> Suspension Bridges with Closed Open Gratings

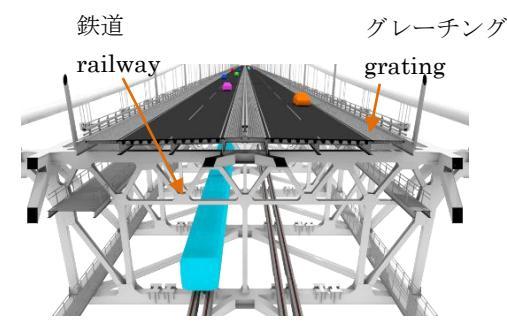
図-1 瀬戸大橋の補剛桁の断面 Fig. 1 Cross section of Seto-Ohashi Bridges

瀬戸大橋に含まれる吊橋3橋(下津井瀬戸大橋(中 央支間長940m、以下同様)、北備讃瀬戸大橋(990m)、 南備讃瀬戸大橋(1100m))の桁断面は共通の2層のト ラス形式で、上層は高速道路(瀬戸中央自動車道)、下 層は鉄道(瀬戸大橋線(本四備讃線))(図-1)として利 用されています。道路床版には耐風安定性を確保する ために中央分離帯と路肩の部分にグレーチング(写真-3) が設置されています。このグレーチングの維持管理上 の課題として、高速道路の落下物などがグレーチング を通って落下し、鉄道の運行に影響を及ぼす可能性な どが挙げられます。

The Shimotsui-Seto Bridge, Kita Bisan-Seto Bridge and Minami Bisan-Seto Bridge (main span of 940, 990, 1100 m, respectively) are combined highway-railway suspension bridges (Fig. 1) in the Seto-Ohashi Bridges. The cross sections of the stiffening trusses of the three bridges are identical with two levels for transportation – the upper level carries highway and the lower level carries rail. In order to improve aerodynamic stability, open gratings are installed at the center divider and each side of the road deck (Photo 3). However, the open gratings present some maintenance and operational problems, such that falling objects on the road deck may slip through them and endanger railway operation.

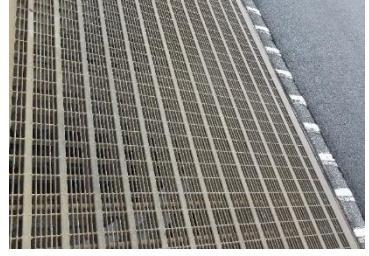
写真・3 瀬戸大橋のグレーチング Photo 3 Open gratings of Seto-Ohashi Bridges

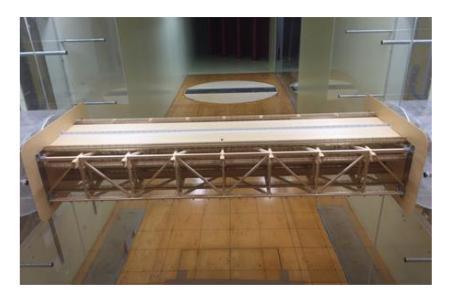
写真・4 部分模型を用いた風洞試験 Photo 4 Two dimensional wind tunnel test

この検討は横浜国立大学との共同研究として行われ ています。解析に必要となる空力特性を得るための部 分模型を用いた風洞試験(写真-4)を横浜国立大学で、 解析を本四高速で実施しています。

This study was conducted jointly with Yokohama National University, using the University's closed-circuit type wind tunnel facility (Photo 4). Using this analysis it was found that all center gratings could be closed except for small sections in the center spans of the bridges. Furthermore, it was found that all the center gratings could be closed if center barriers are used at some portions of center span. For the actual implementation, the detailed arrangements for closing gratings will be studied.

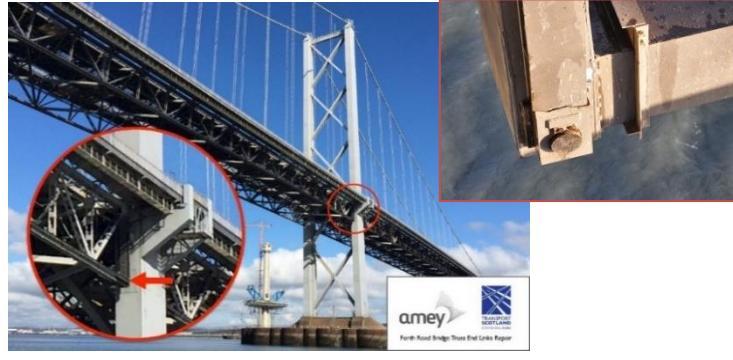
写真-5 破断したエンドリンク Photo 5 Location of Damaged Link

AMEY 社は、2015年6月1日よりフォース河口運輸 公社に代わって、フォース道路橋の運営、維持、管理 を実施しています。フォース道路橋は中央支間長が 1,006m、側径間がそれぞれ408mです。本橋梁では、中 央径間北東側のエンドリンクで破断が発見され、2015 年12月3日から約3週間、通行止めとなりました(写 真-5)。本橋梁の交通量は78,000台/日で、その内9%が 大型貨物車です。

On June 1, 2015, AMEY on behalf of Transport Scotland took over responsibility for the operation, management and maintenance of the Forth Road Bridge from the Forth Estuary Transport Authority (FETA). The bridge has a main span of 1,006 m. The side spans are each 408 m long. The bridge was unexpectedly closed to traffic on December 3, 2015 for almost three weeks after a truss-end link at the north-east corner of the main span was discovered to have failed (Photo 5). The bridge carries about 78,000 vehicles a day, 9% of which are heavy goods vehicles.

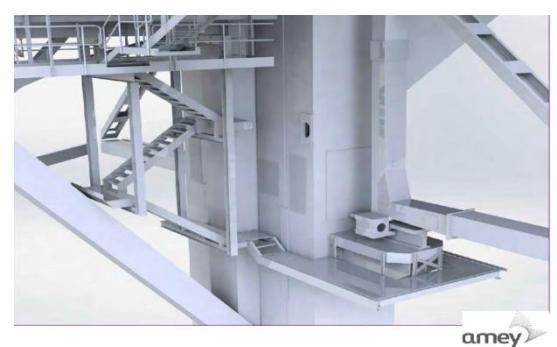
図·2 エンドリンクの補強完成図 Fig.2 Image of Repair Completed

2016年8月にはエンドリンクの交換作業は最終段階 に入り、併せて、補強案の比較検討と、それに続いて の最適案の設計が行われました。続いて、北東側エン ドリンク部への新しい構造の試験施工が2017年初頭に 始まりました。残りのエンドリンクは撤去され、代わ りにトラス端部の下に、主塔からブラケットを張り出 し、その上に滑り支承装置を設置しました(図-2)。

The final phase of work to replace the Forth Road Bridge's truss end links arrangement began in August, 2016 with the consideration of options and thereafter the design of the preferred option. A trial of the construction of the new design at the north east main span truss end links began in early 2017 that proved successful. The remaining seven truss end links are being replaced by contractor C Spencer with a new permanent sliding bearing arrangement attached to a large bracket attached to the main towers beneath the end posts of the suspended truss (Fig. 2).
