長大橋NEWSレター

NO. 18

NEWSLETTER on Long-Span Bridges

本州四国連絡橋公団 長大橋技術センター 平成15年12月
Long-Span Bridge Engineering Center, Honshu-Shikoku Bridge Authority,
December, 2003

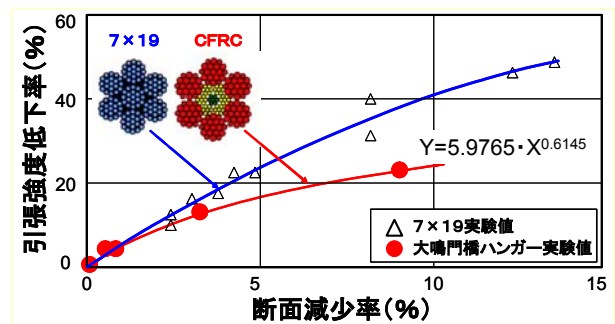
図-1 断面減少率と引張強度低下率の関係
(Fig.1 Relation between sectional area reduction rate and tensile strength reduction rate)

開放調査の結果、定着部を除く一般部の腐食については、腐食率は断面積の1%以下で因島大橋のそれとほぼ同じ傾向でした。しかし、定着部については、最大で断面積の9%程度の腐食が確認され、因島大橋とは異なる傾向にありました。引張試験は、腐食率(非破壊検査値)の異なるロープを対象に4本について行いました。その結果は、図-1に示すとおりで、9%の腐食率に対して、約23%の引張強度の低下が見られました。引張試験の結果をもとに、今後の安全率の低下予測を行いました。一般部は100年後においても十分な安全率を有しますが、定着部については、20年～30年後には所要の安全率を下回る結果となりました。このため、当面は、定着部に限定した長寿命化対策に取り組むことにしました。

As the result of visual inspection, degree of corrosion in general part is 1% or less of sectional area and this indicates a similar tendency to the Innoshima Bridge. However, as for anchoring part, a maximum of 9% corrosion of sectional area was found, and this is different from the Innoshima Bridge. Tensile tests were conducted for four parts of suspender ropes with different corrosion rate (based on non-destructive testing result). Test results suggested that tensile strength is reduced by 23% in the suspender rope with 9% of corrosion rate (shown in Fig.1). Prediction of safety ratio in the future based on the tensile test indicates that a suspender rope in general part has enough safety factor in 100 years, but the factor falls below the required level in twenty or thirty years in anchoring part. With these results, HSBA decided to investigate and develop counter measures to protect the anchoring part to enhance the durability of the bridge.

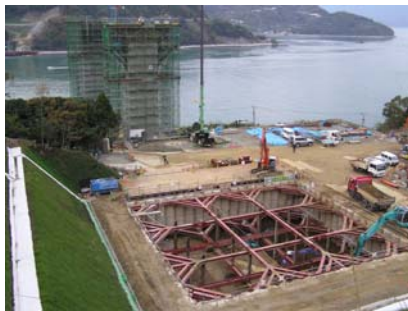
写真-4 4A 施工状況

第7号で紹介した豊島大橋の本格的な工事が始まりました。豊島大橋は、広島県が地域産業の振興、地域住民の利便性の向上、広域市町村圏の充実など総合的発展のために建設を進めている安芸灘諸島連絡橋3号橋として、安芸郡蒲刈町の上蒲刈島と豊田郡豊浜町の豊島との海峡部を渡海する橋梁です。現在、陸上部下部工の施工を行っており、写真-4は土留め工を施工している4Aアンカレイジです。

The construction work for the Toyoshima Bridge was begun. The outline of this bridge was reported on No.7 of the Newsletter. The Toyoshima Bridge is the 3rd bridge of the Aki-Nada Islands Bridge Project, and connects the town of Kamagari in the Kamikamagari Island with the town of Toyoshima in the Toyoshima Island. This bridge is expected to contribute the development of the industry and the improvement of the convenience in the region around. Currently, the construction of the foundation on the land is underway. Photo.4 shows the retaining wall for the 4A anchorage on the Toyoshima side.

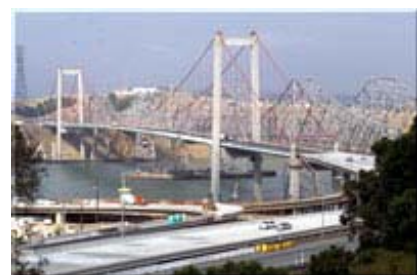
写真-6 新カルキネツ橋

New Carquinez Bridge, which spans the San Francisco Bay in California, U.S.A., was completed and the opening ceremony was held on November 8. This bridge is replaced with the old bridge built in 1927. The construction of this bridge was started in summer of 1999 as a part of the Seismic Retrofit Program for the bridges in San Francisco area. The new bridge is a suspension bridge with a total length of 1,055m and a center span length of 728m. This bridge carries 4-traffic-lane highway.

This bridge is the first major suspension bridge in the United States since the completion of the Chesapeake Bay Bridge (1973) and is the first suspension bridge in the U.S. with stream-lined box girder, concrete main towers, and pile foundations. It is also noteworthy that concrete towers were used in a high seismic zone for the first time in the world.

技術的な特徴として、米国では 1973 年完成のチェサピークベイ橋以来の大規模吊橋であり、米国の吊橋では初めて流線型鋼床版箱桁、コンクリート製主塔、杭基礎を採用しています。また、強地震域に世界で初めてコンクリート製主塔を採用した点も特筆すべき点です。(以上の情報及び写真は、Caltrans、その他関連のホームページ等による。)
